FMW Renovation Update

November 25, 2018

Long-awaited underpinning begins this week.

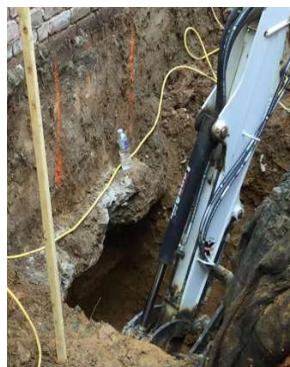
No pins are involved. The concrete crew digs a hole under a few feet of the existing foundation and pours a newer and deeper foundation, then moves a few feet and repeats the process until a whole section of the building is done.

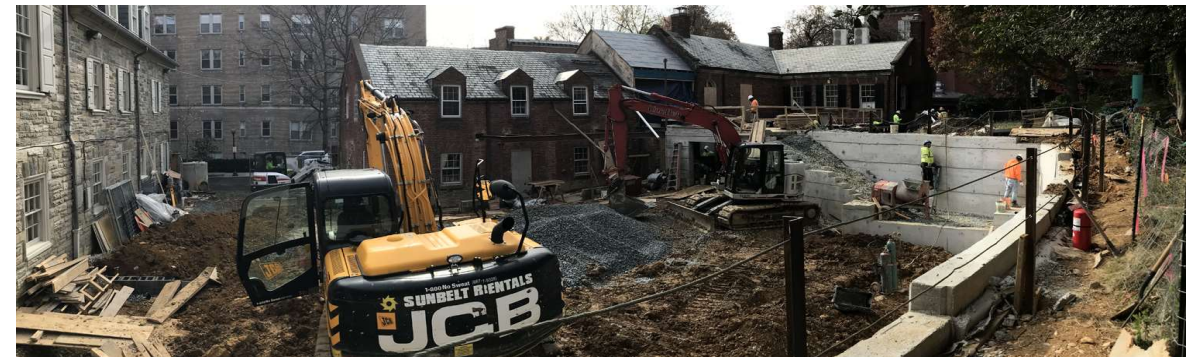
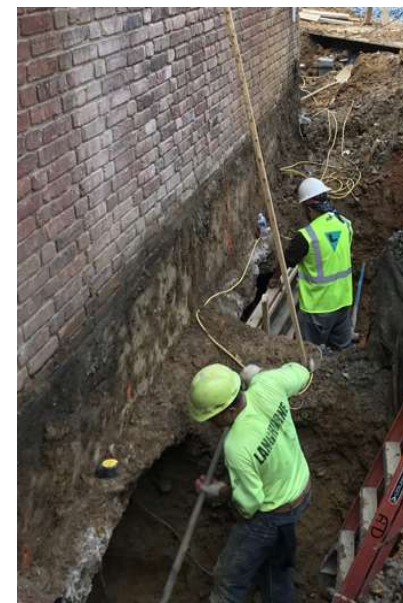
The underpinning begins with the digging of several holes under the Carriage House east wall.

By day's end, steel and forms are placed and concrete is poured.

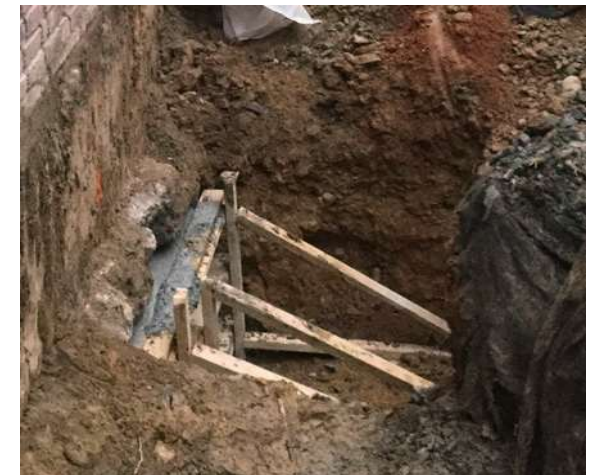
Meanwhile, cement masons apply anti-blemish treatment to the new retaining wall.

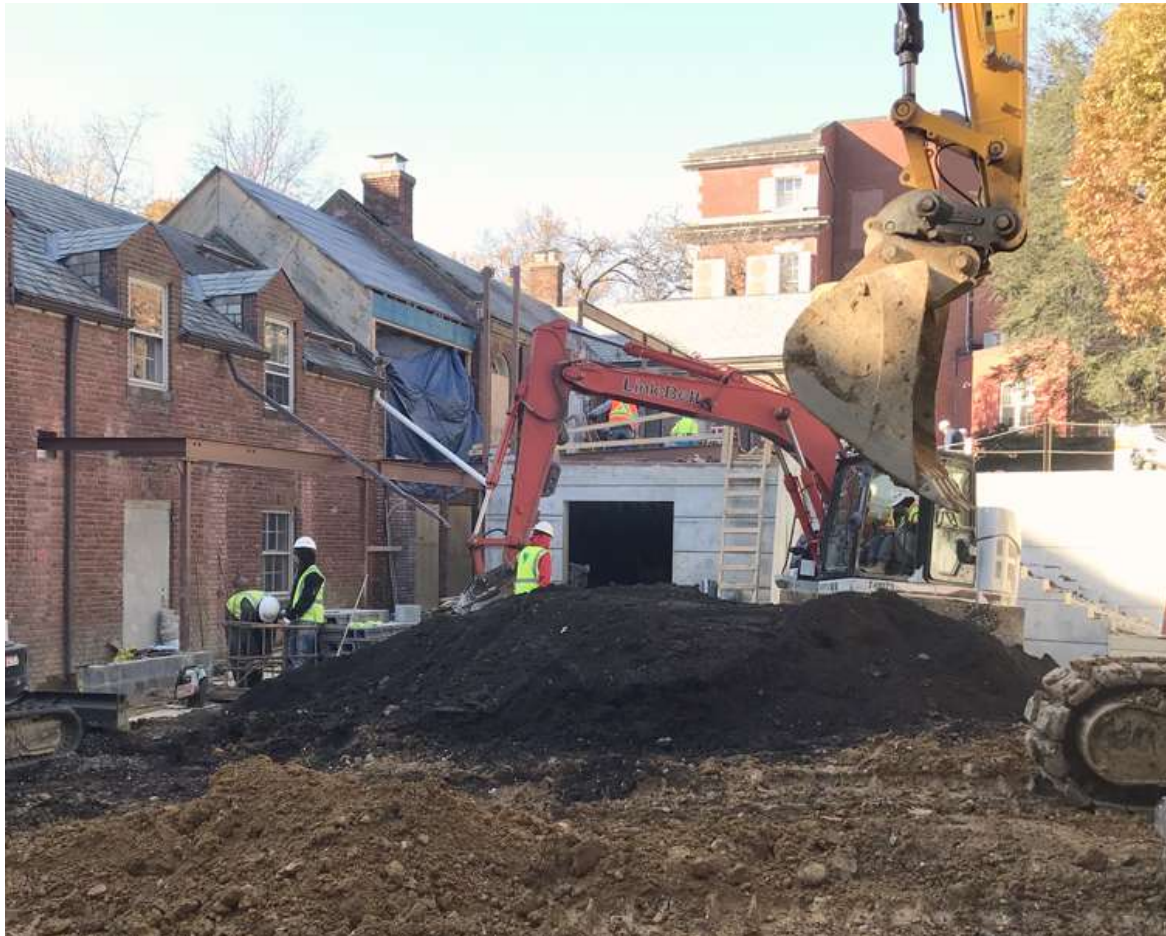
The arrival of new topsoil — the first of many truckloads — brings a refreshing contrast to the brown mud that has so far dominated the scene.

Excavators scoop it up onto the upper terrace and spread it out.

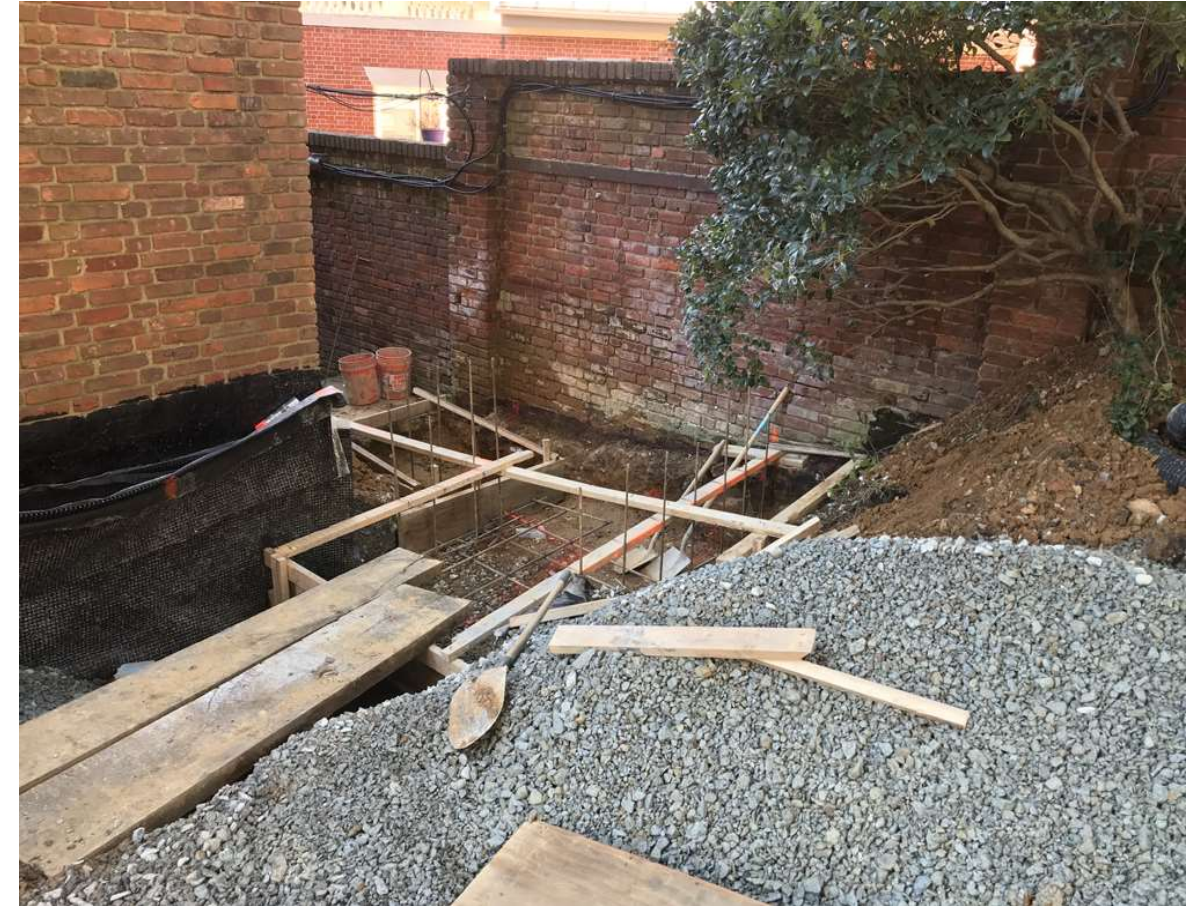
The black waterproofing on the wall shows where the new ground level will be.

The orange buckets show where the bottom of the stairs will begin.

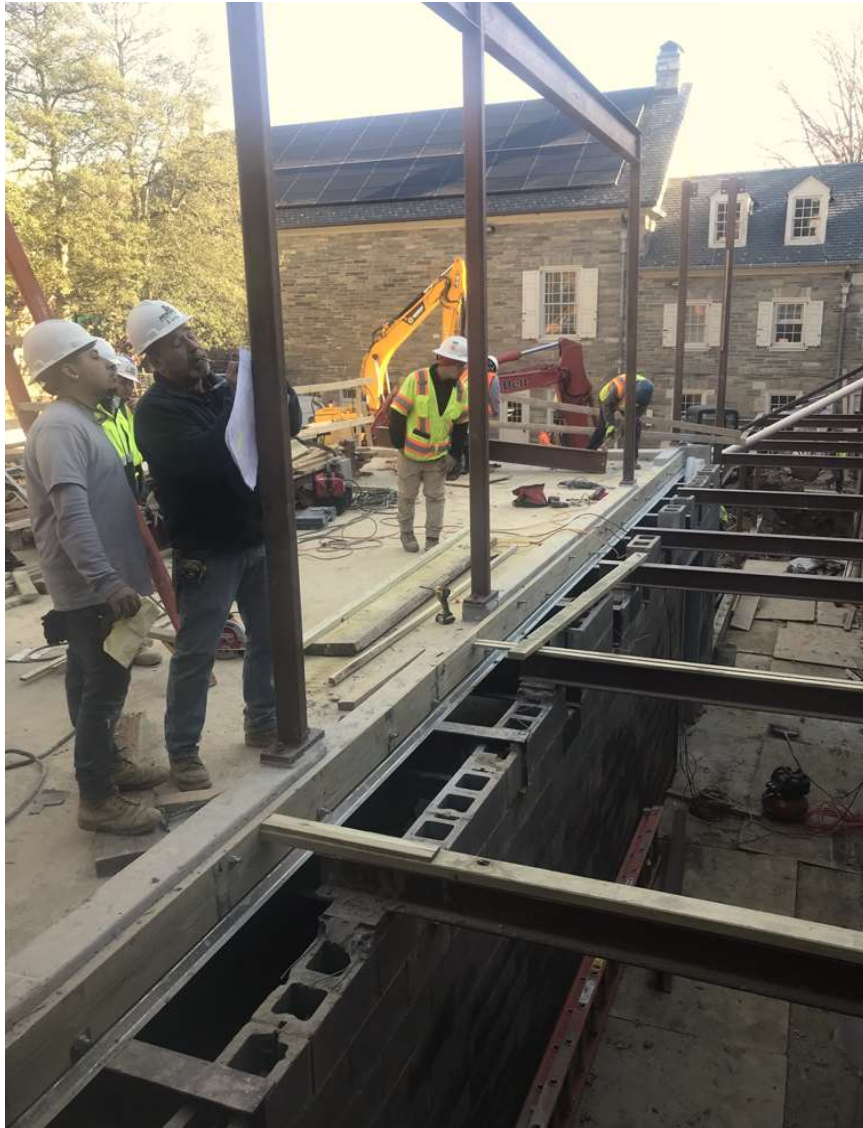
Monarc Project Superintendent Steve Lail verifies the spacing of two steel posts, where the corridor will widen out to create a small foyer outside Quaker House Living Room.

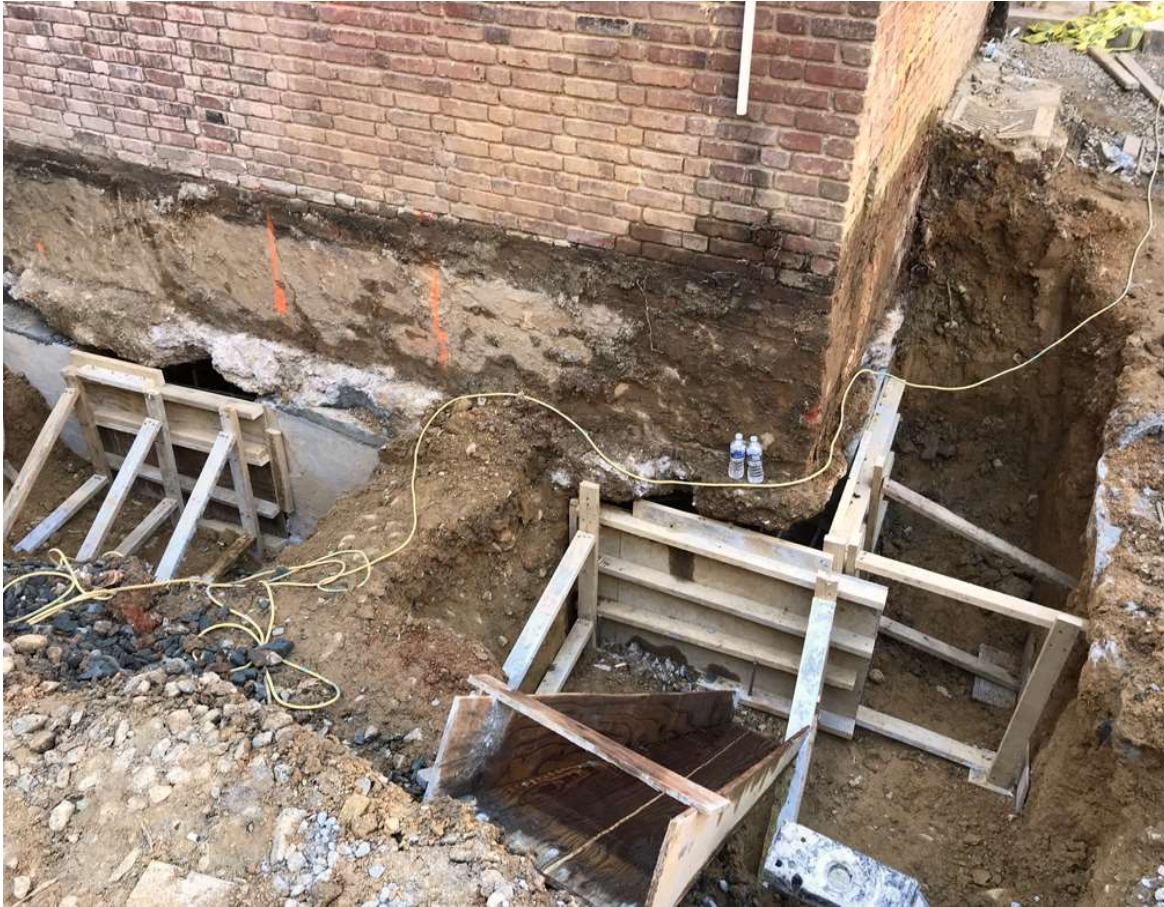
The concrete crew now excavates the spaces between the newly poured underpinning and installs forms to pour the second stage.

They also continue work on the upper garden stairs.
At the end of the day, more concrete is poured.

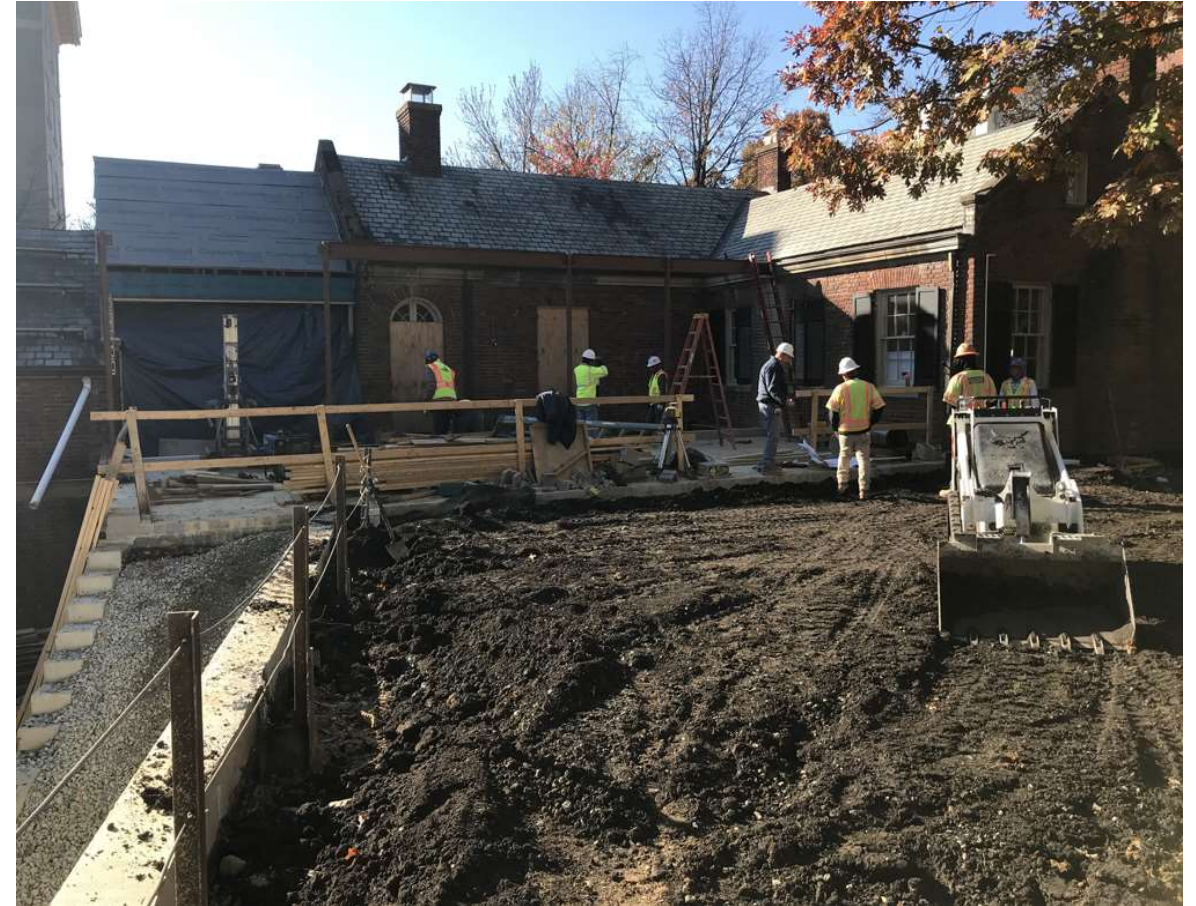
The excavators continue to backfill topsoil on the upper terrace. The shape and size of that terrace are now quite visible, with the new steel marking the new doors in the back.
