FMW Renovation Update

December 9, 2018

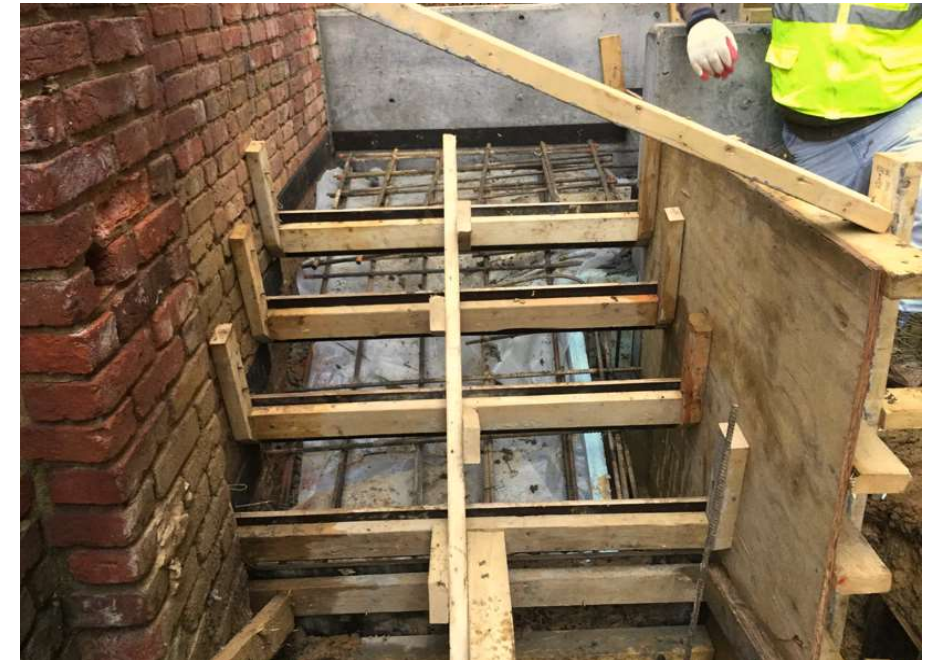
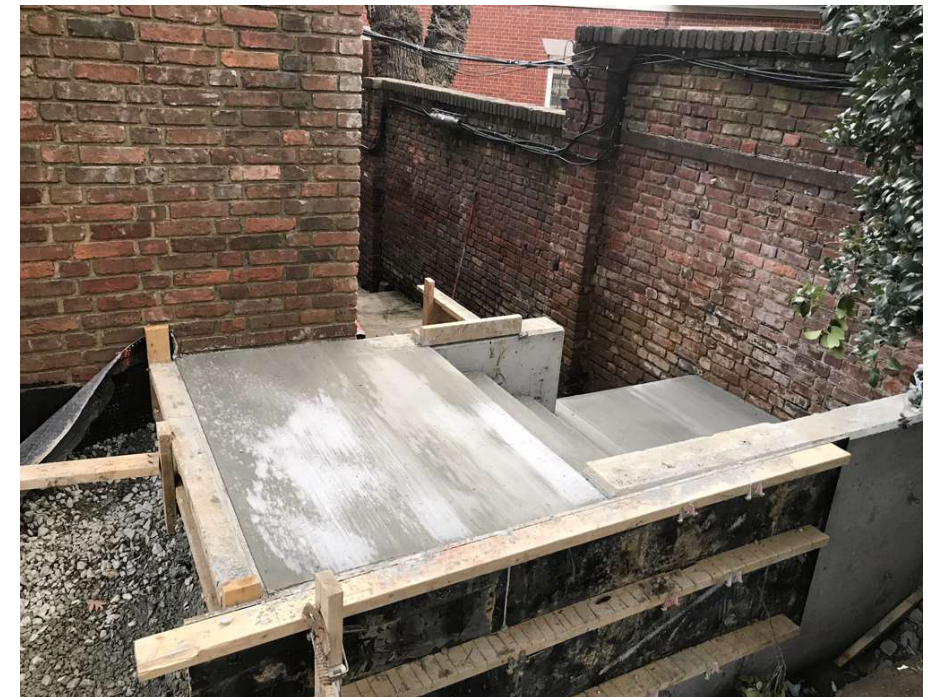
The day begins with preparations to pour the soon-to-be-little-used west stairs.

And ends with the stairs firmly in place.

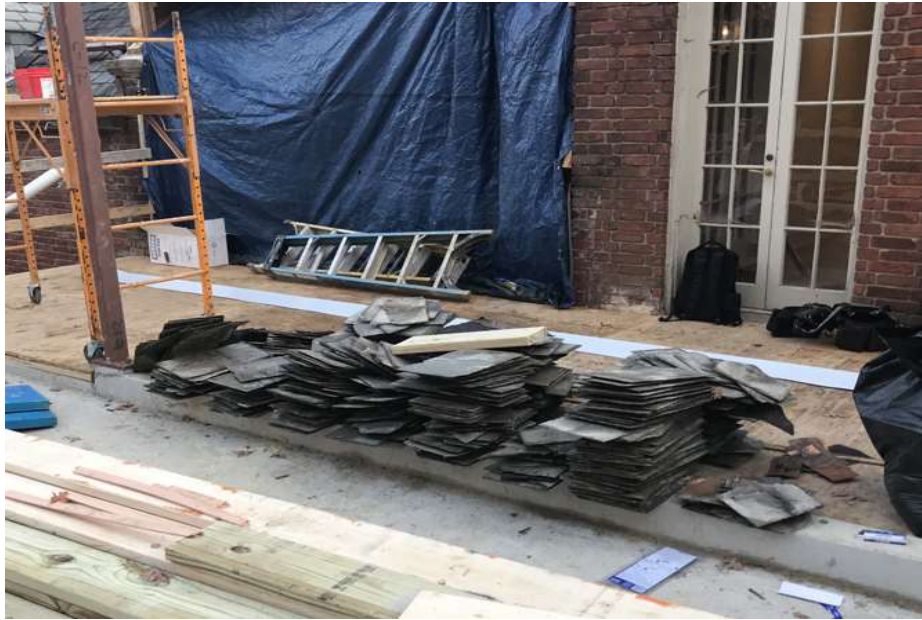
Nearby, roofers remove the old slate shingles from the Quaker House roof.

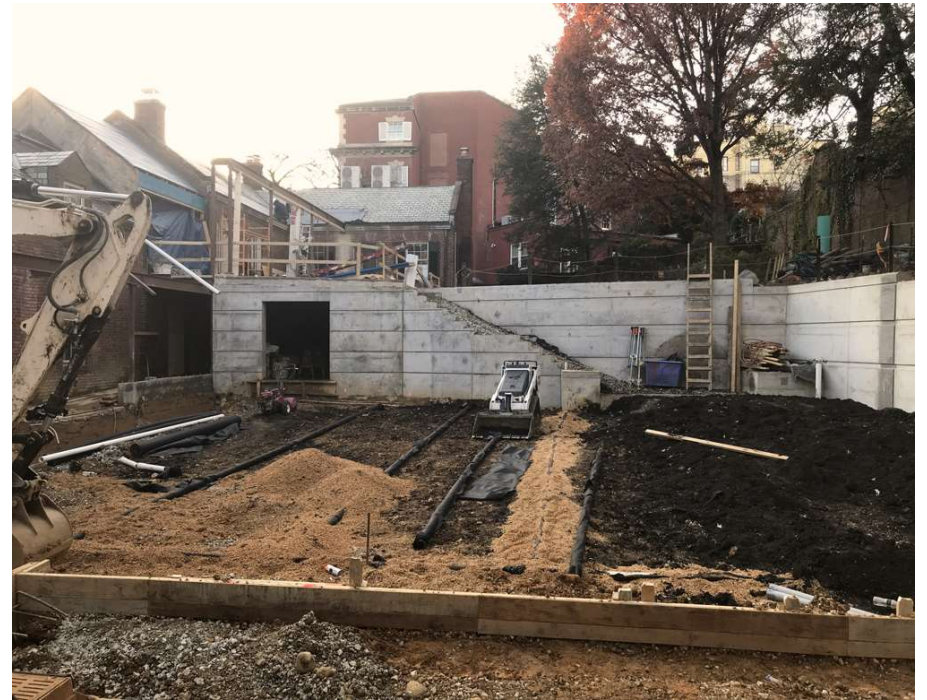
The site utilities crew continues to till topsoil into the clay and install underdrains, working southward on the lower terrace.

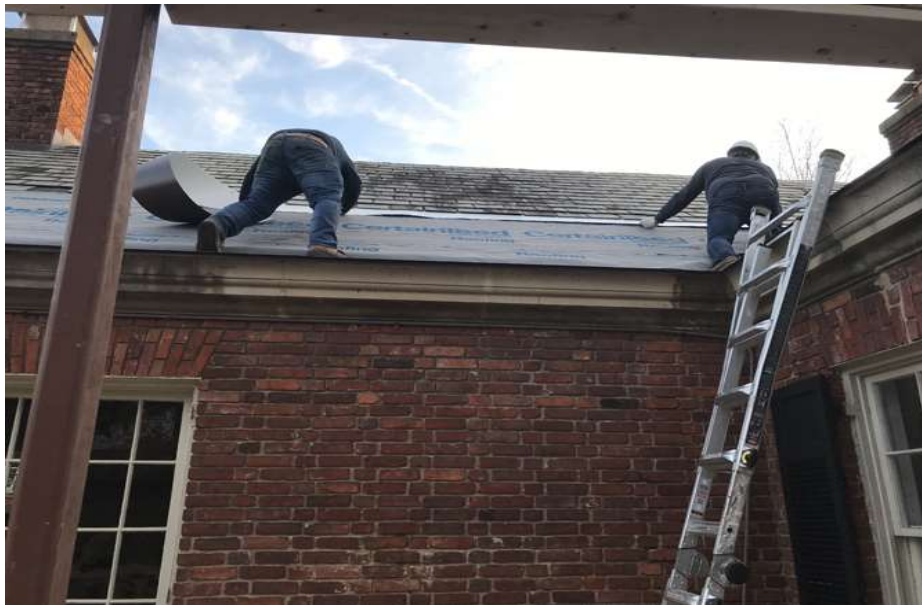
And apply waterproofing, as they prepare to tie in the new corridor roof.

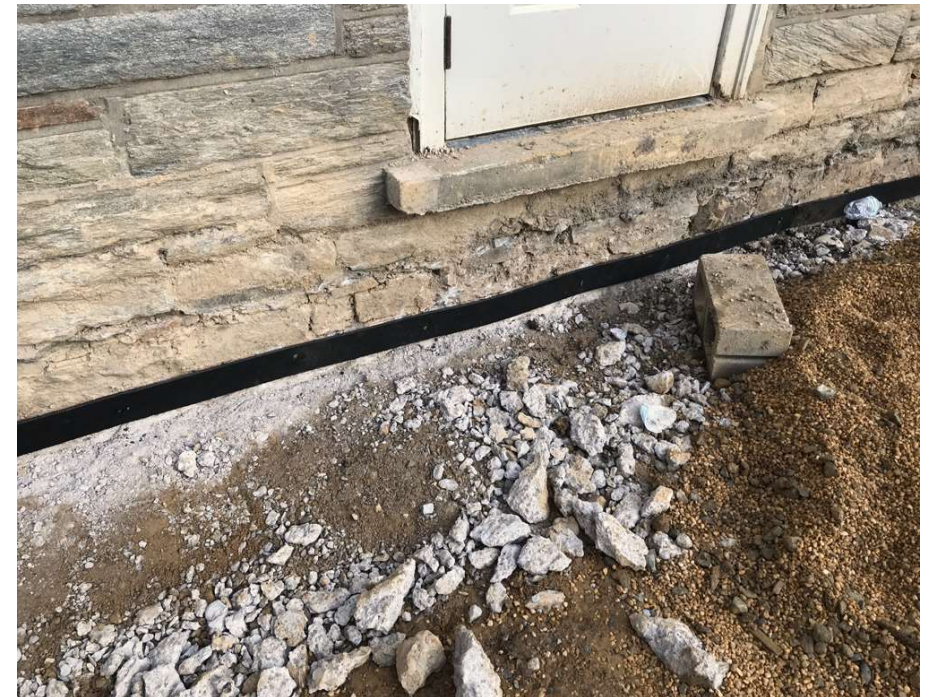
The concrete crew chips away at the Meeting House, preparing to pour the slab for the bluestone patio outside the Assembly Room.

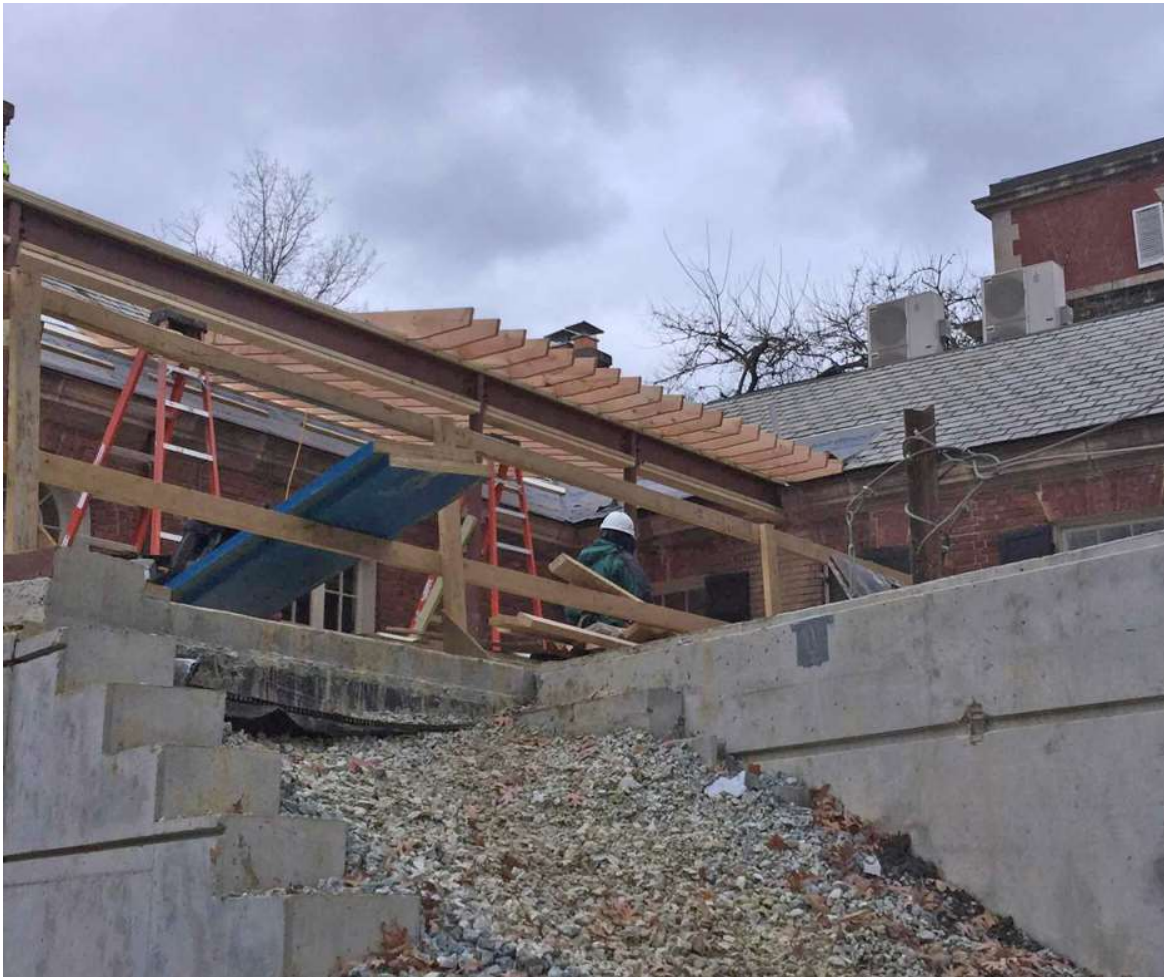
Carpenters three raise their sights and start to frame in the Quaker House corridor roof, making considerable progress.

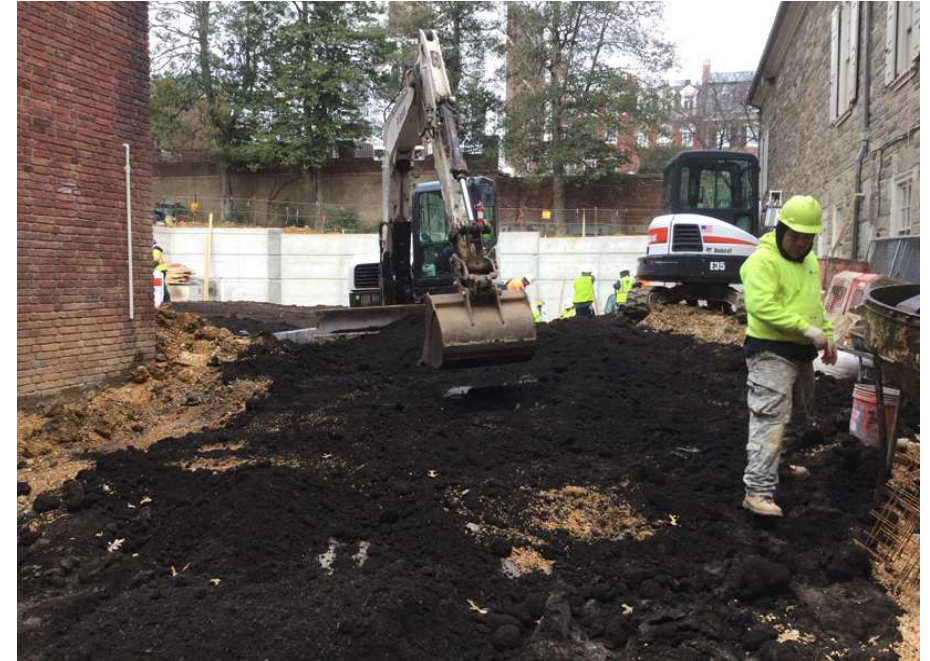
A busy site utilities crew starts to fill in almost two feet of topsoil to raise the lower lawn to its final grade

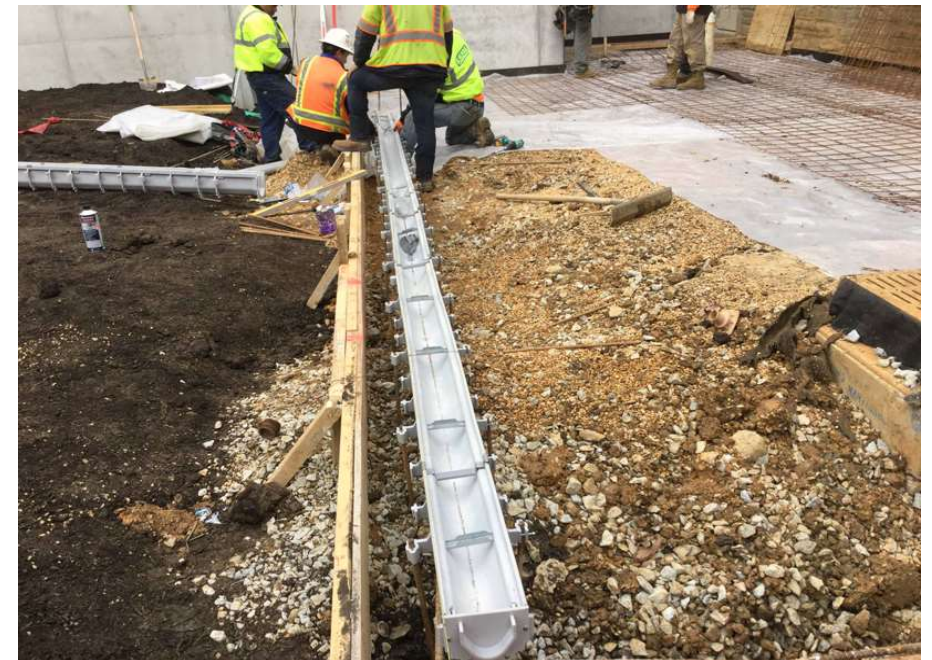
and installs an important trench drain for the foot of the new patio.

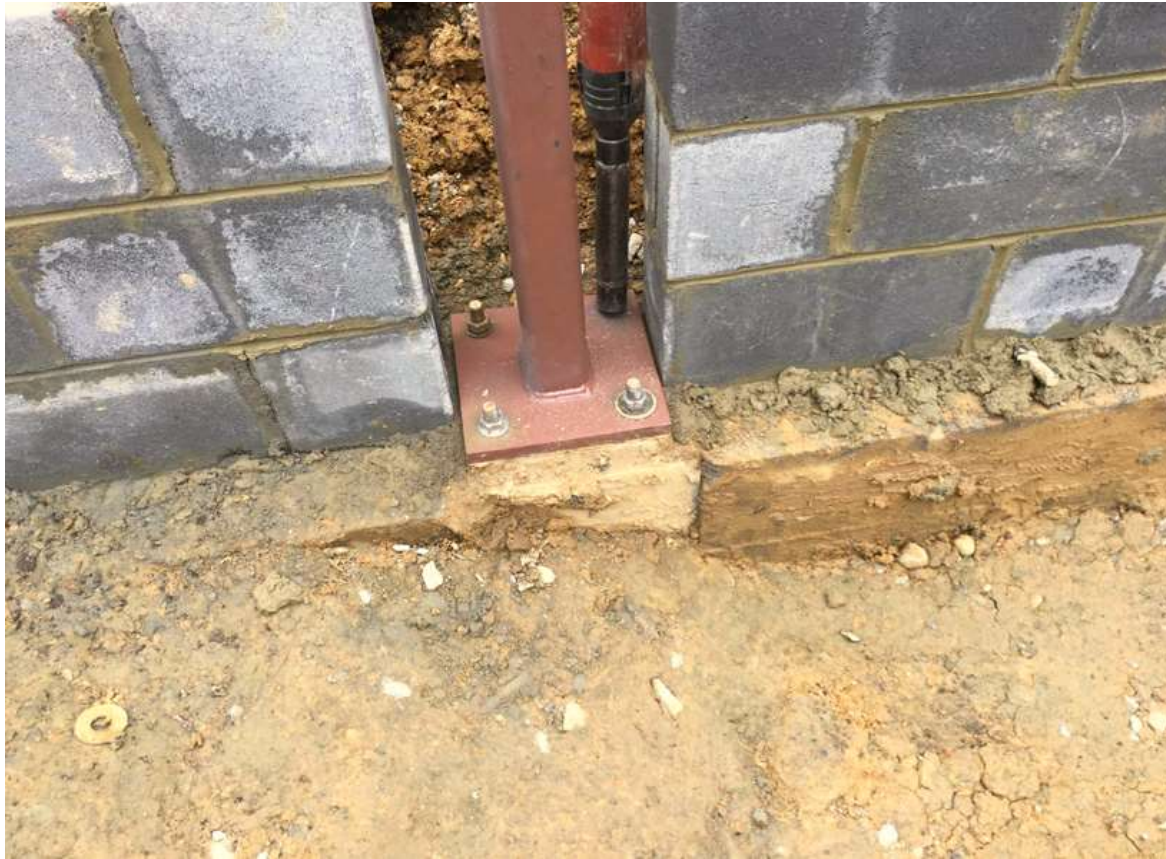
Ironworkers install more steel, expanding the corridor east and up.

This post, being bolted to the corridor foundation, will be cemented into the adjoining stem walls and support the Carriage House upper corridor and roof.

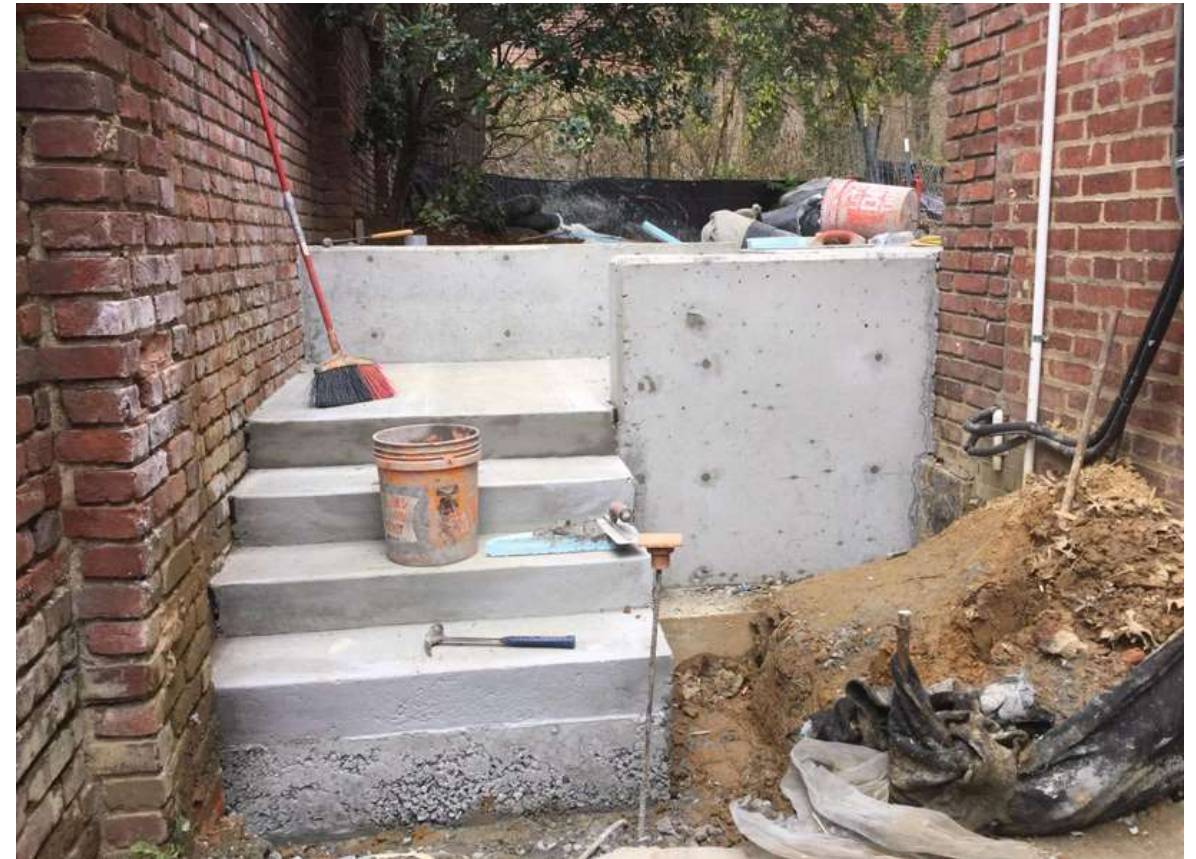
Masons correct and continue concrete block walls for the base of the corridor.

The concrete crew continues to prepare for the patio slab and points up the new west stairs.

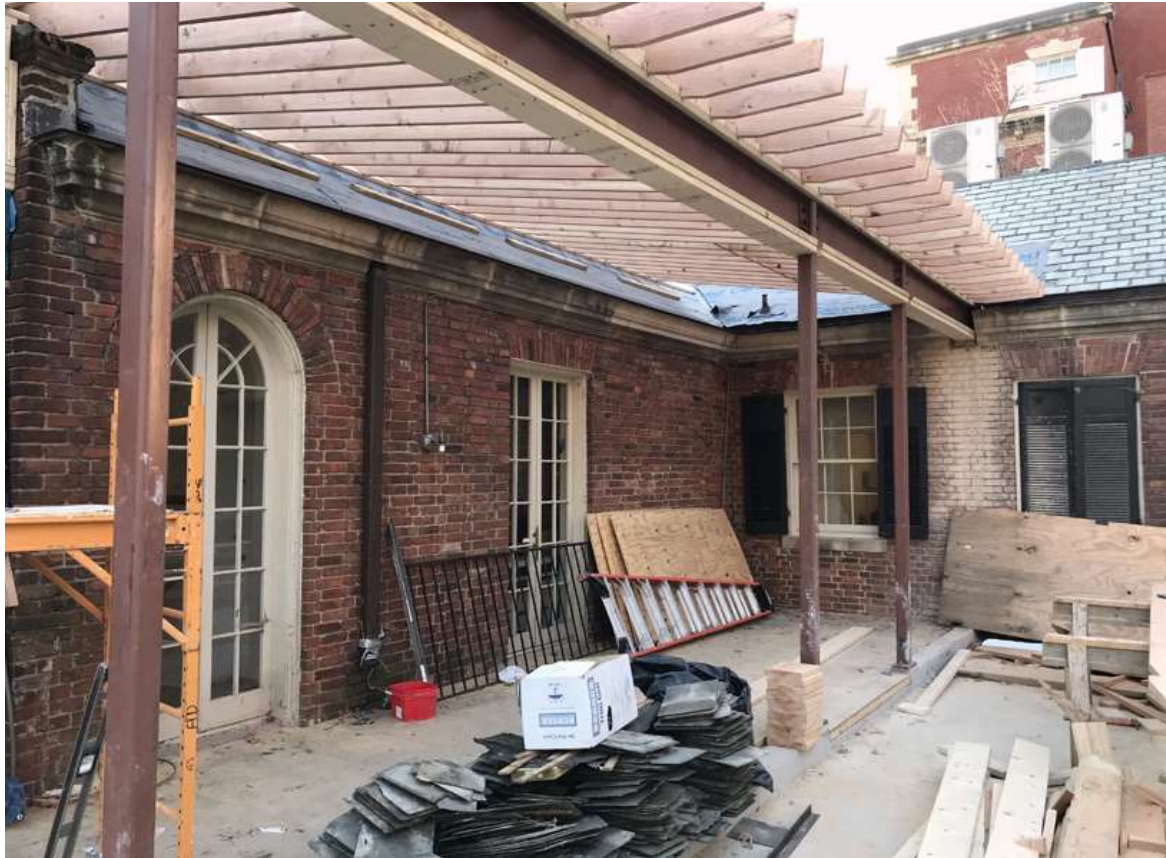
Four of them continue framing at Quaker House Living Room

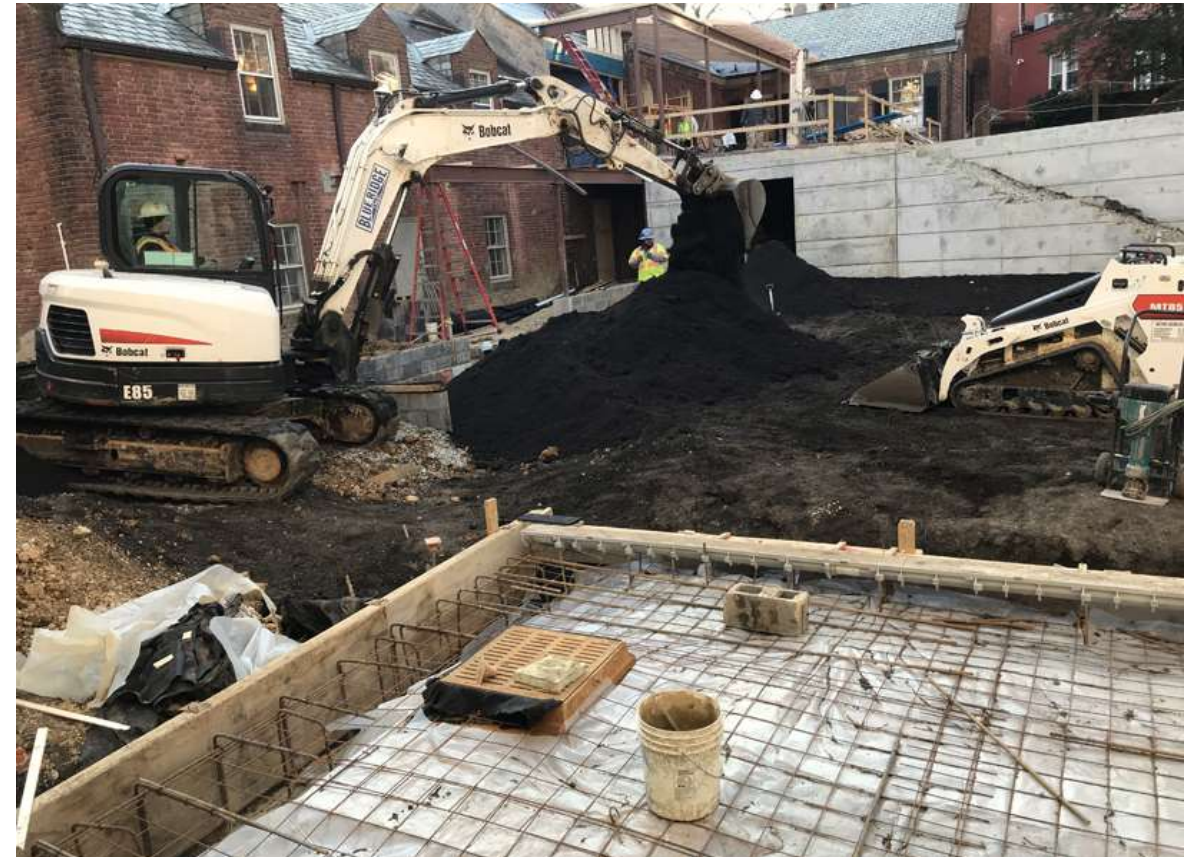
Topsoil continues to pour in,

while steel mesh is installed around the drains to reinforce the new patio.

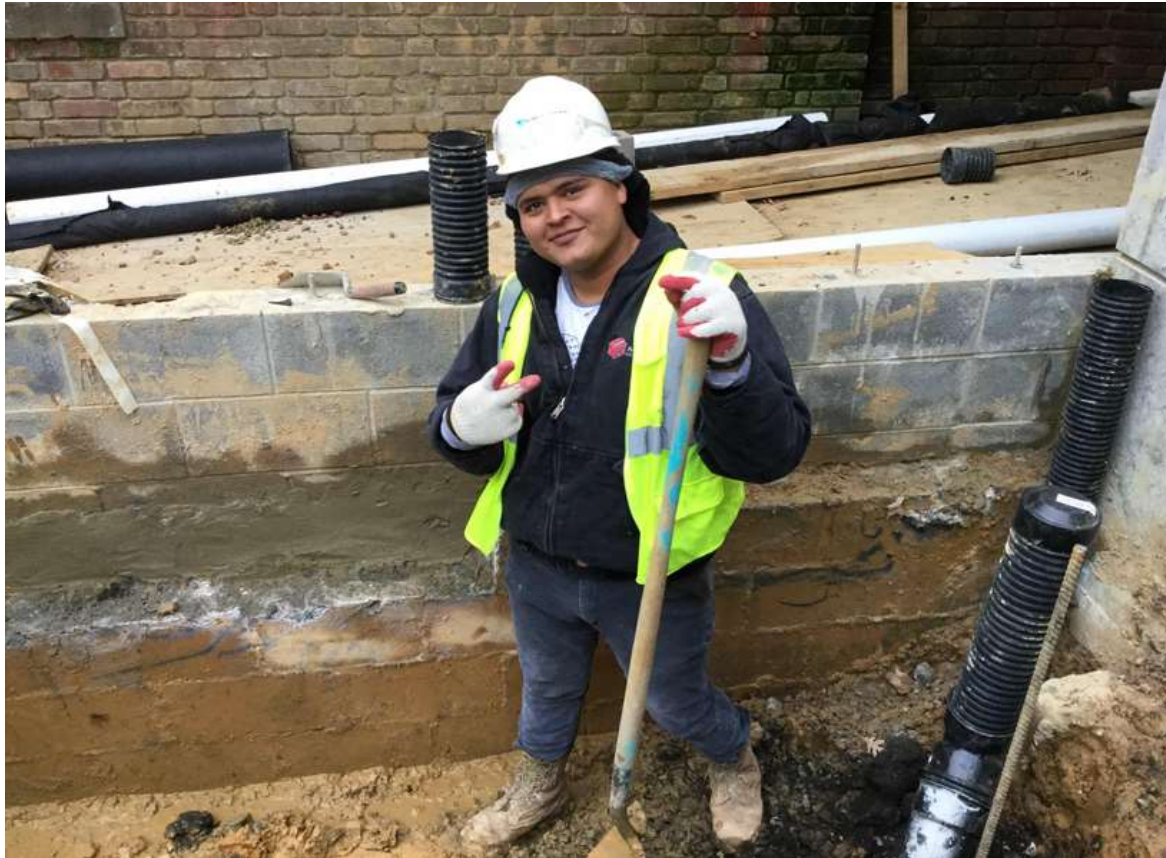
He's engaged in helping to clean the mud off the foundation so that parging (a thin protective layer of concrete) can be applied.

To his left, you can see the newly installed drain that will receive water from the new downspout that will come down from the new roof.

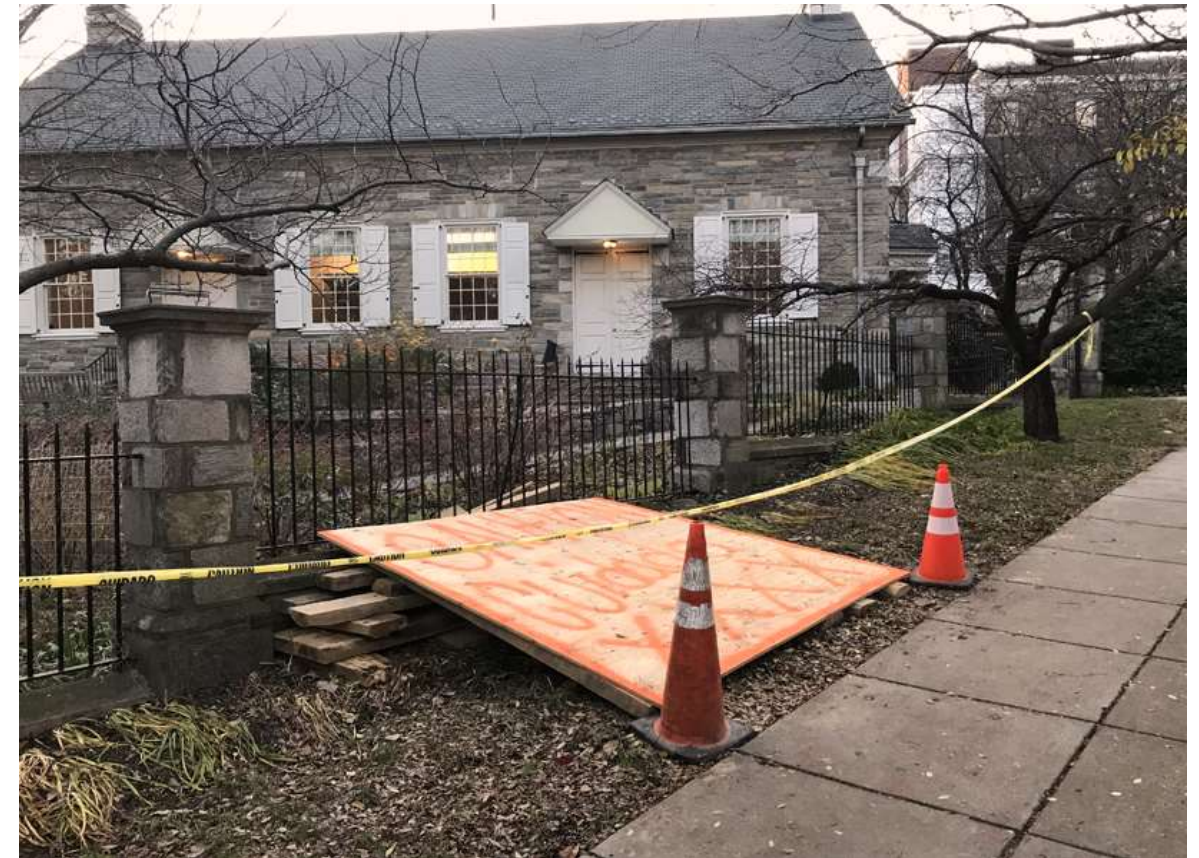
Douglas assembles scraps of wood to continue ramping up to the Phelps Place wall for an invasion of construction equipment next week.

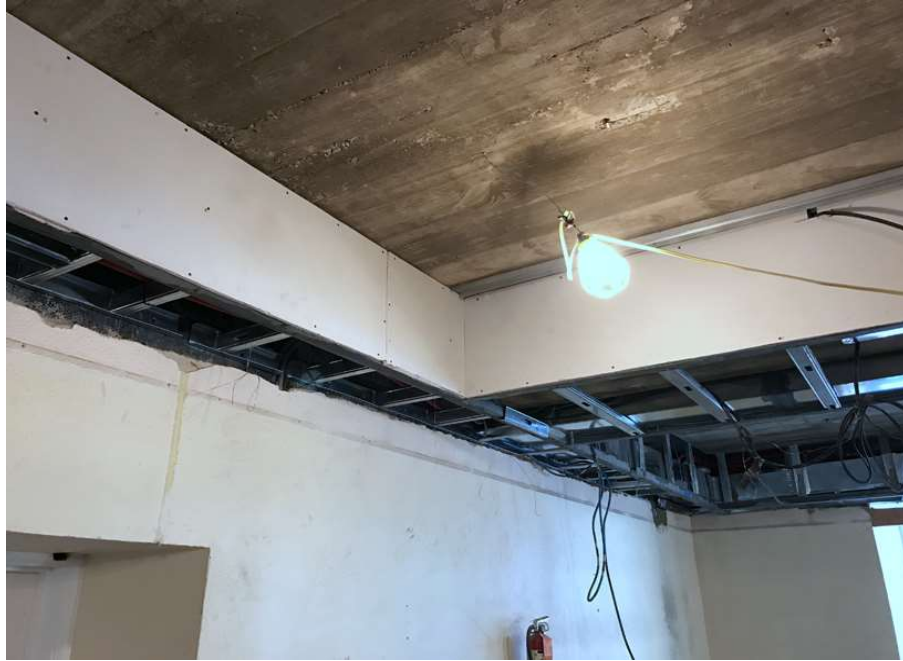
With electrical, plumbing, and ductwork nearing completion, drywall makes it's debut on the Assembly Room bulkheads.

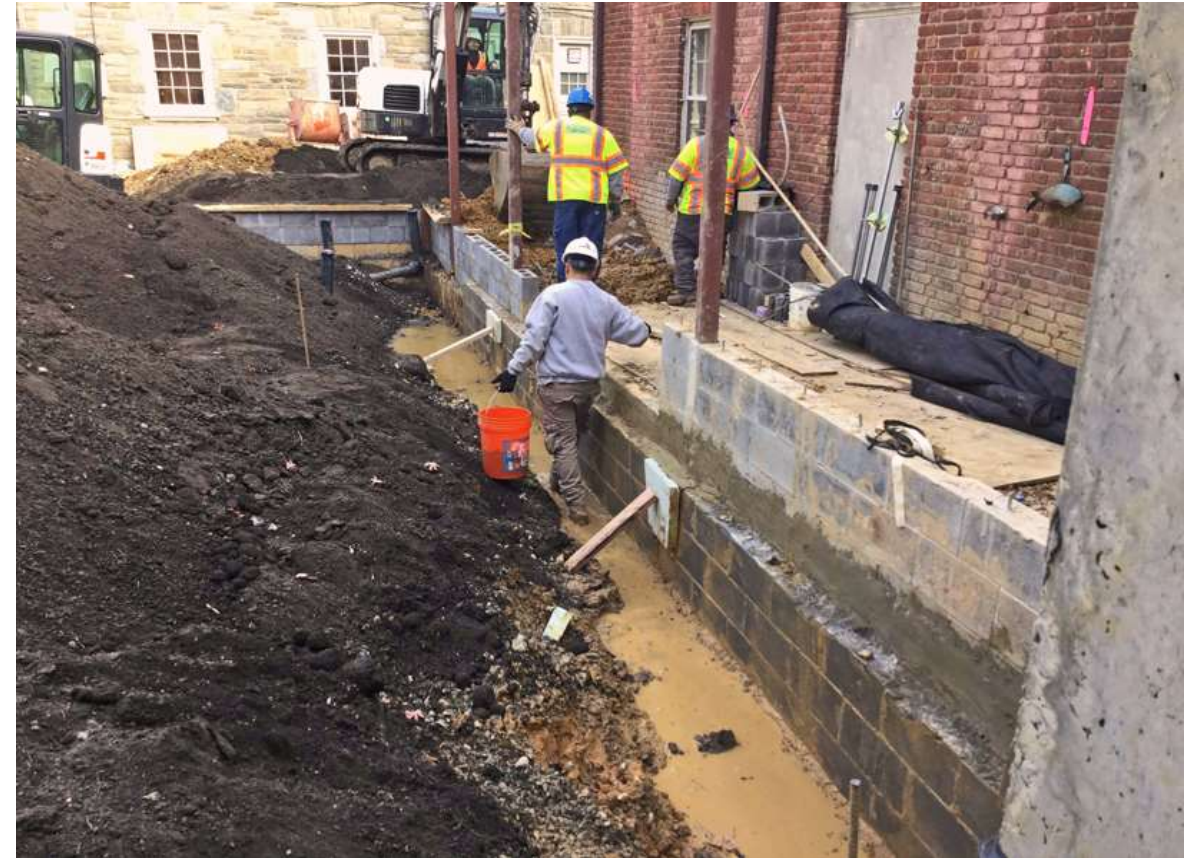
The flood of new topsoil continues to pour into the Assembly Room Terrace, held back on the south side by the efforts to clean off and waterproof the corridor foundation wall.

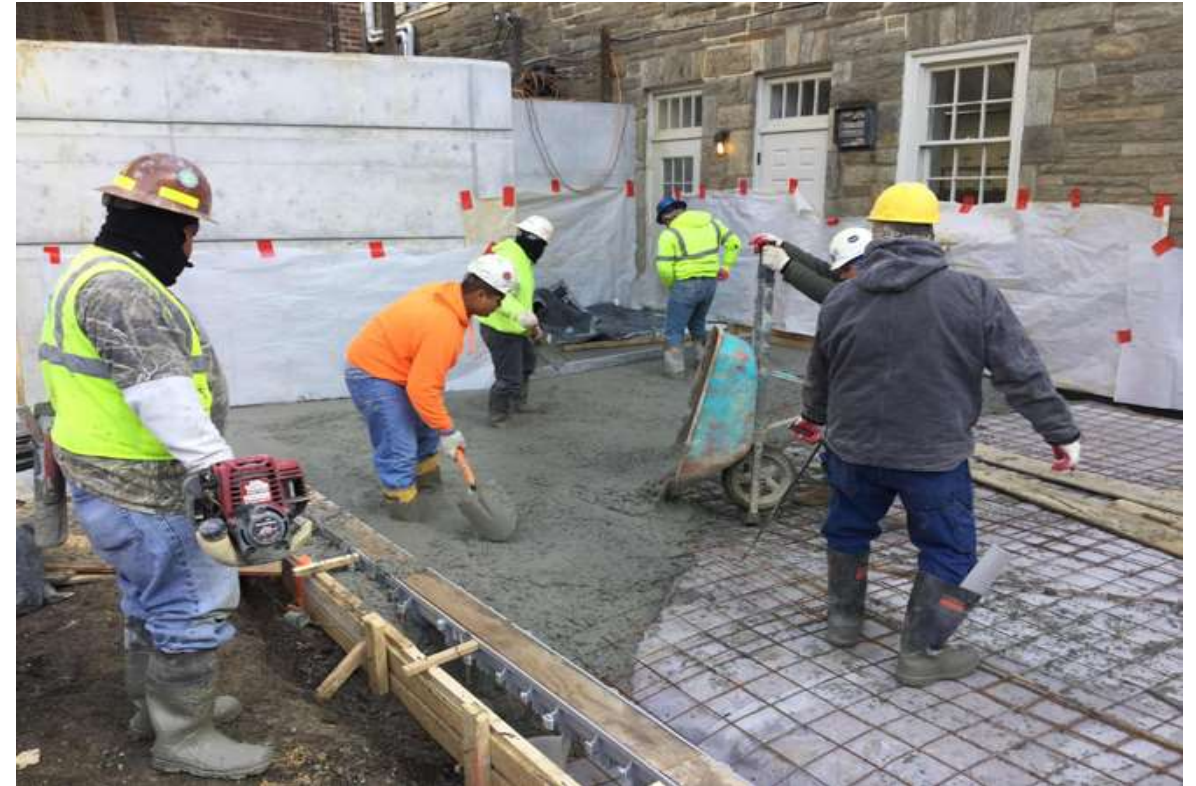
The concrete crew pours the patio.

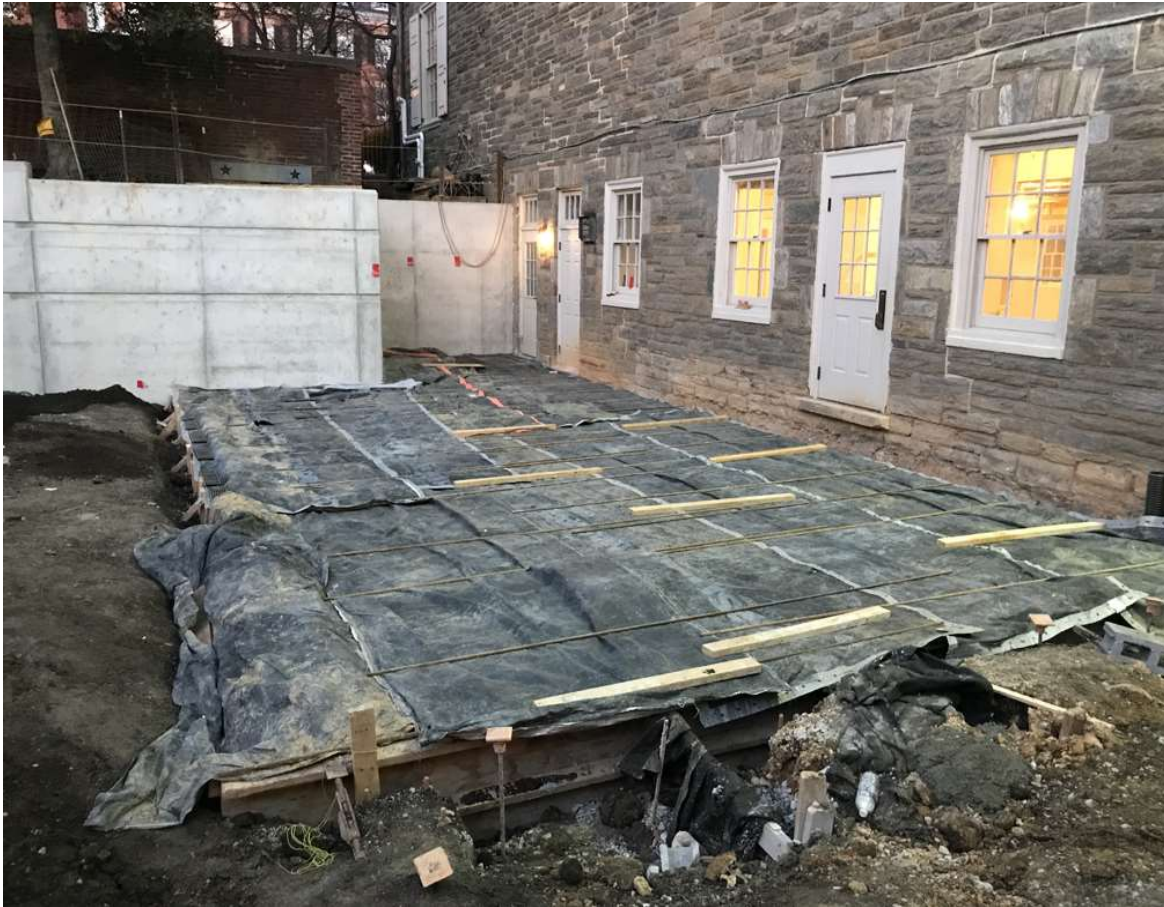
It's going to be a cold night, and concrete should stay above 40° when it's setting, so they cover it with a blanket.

Concrete produces heat as it sets, so it will keep itself warm enough. They had a blanket on the area the night before, as well, to keep the ground from getting too cold overnight.

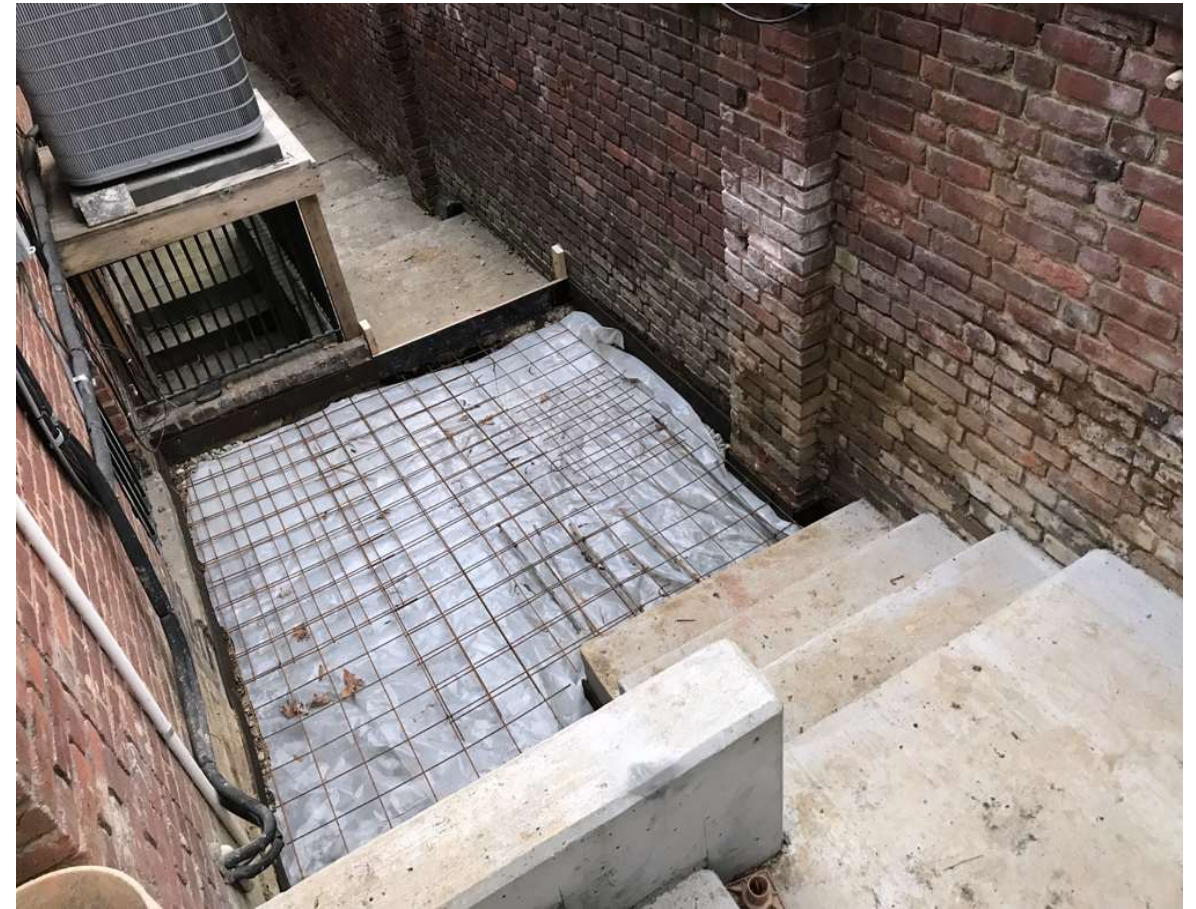
The concrete crew also prepares for one more pour at the new west stairs — a slab to connect the bottom of the new stairs with the top of the old.

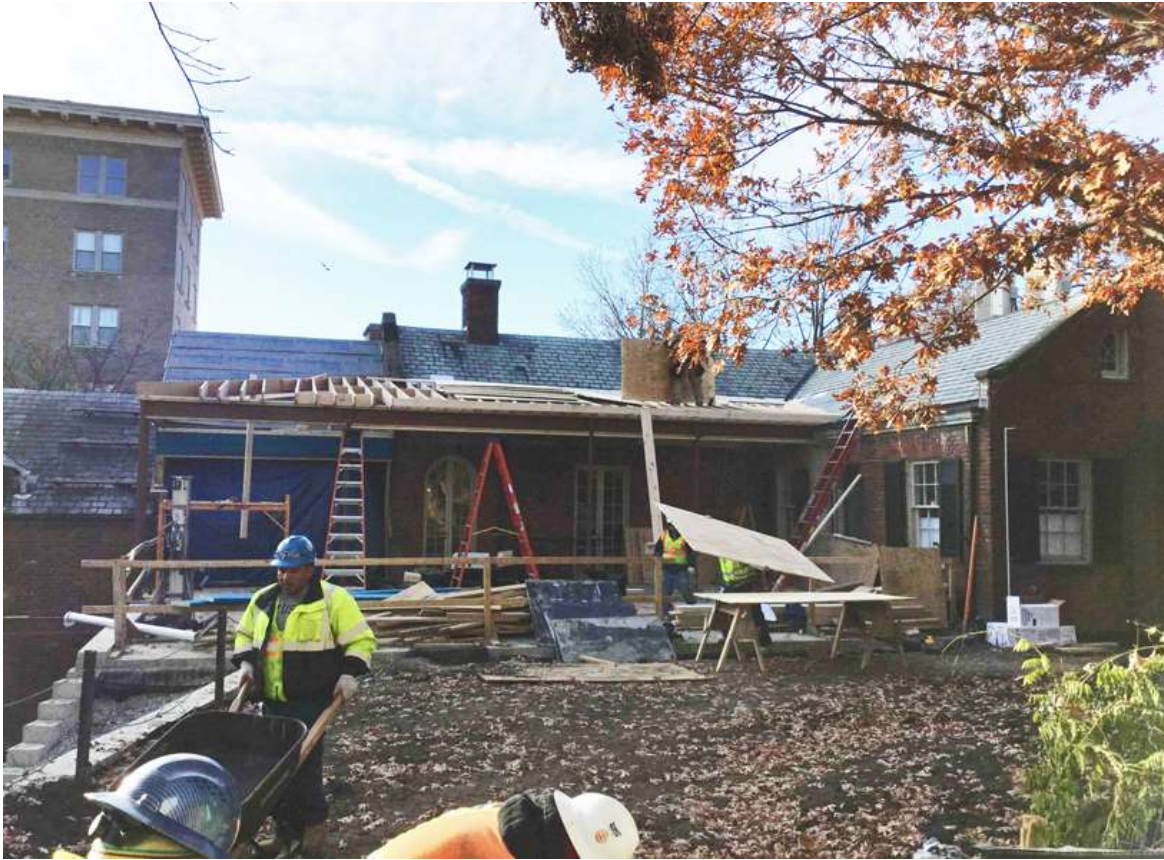
Carpenters also start roof sheathing at Quaker House.

The corridor is starting to feel like a thing.

You can see that the roof is going to have to do several tricks in order to transition gracefully across pitched roofs at three different heights. Let's hope that it is up to the task.

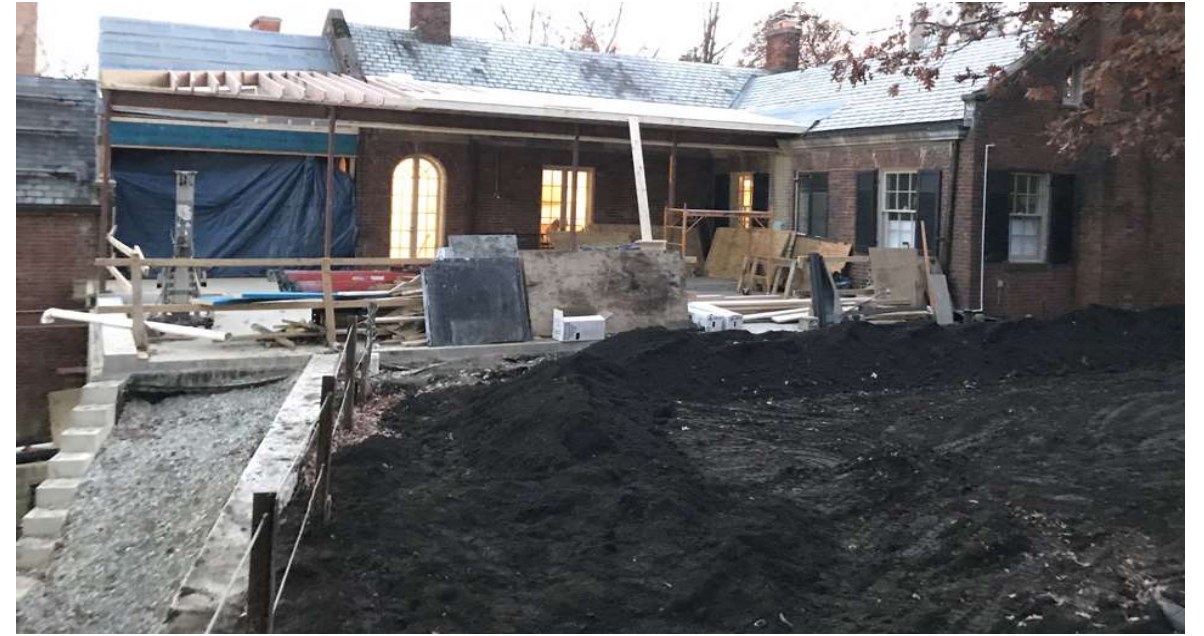
More topsoil arrives, and backfill continues on the upper terrace.

Completion waits for the final waterproofing details at the top of the walls.
