## FMW Renovation Update

September 23, 2018

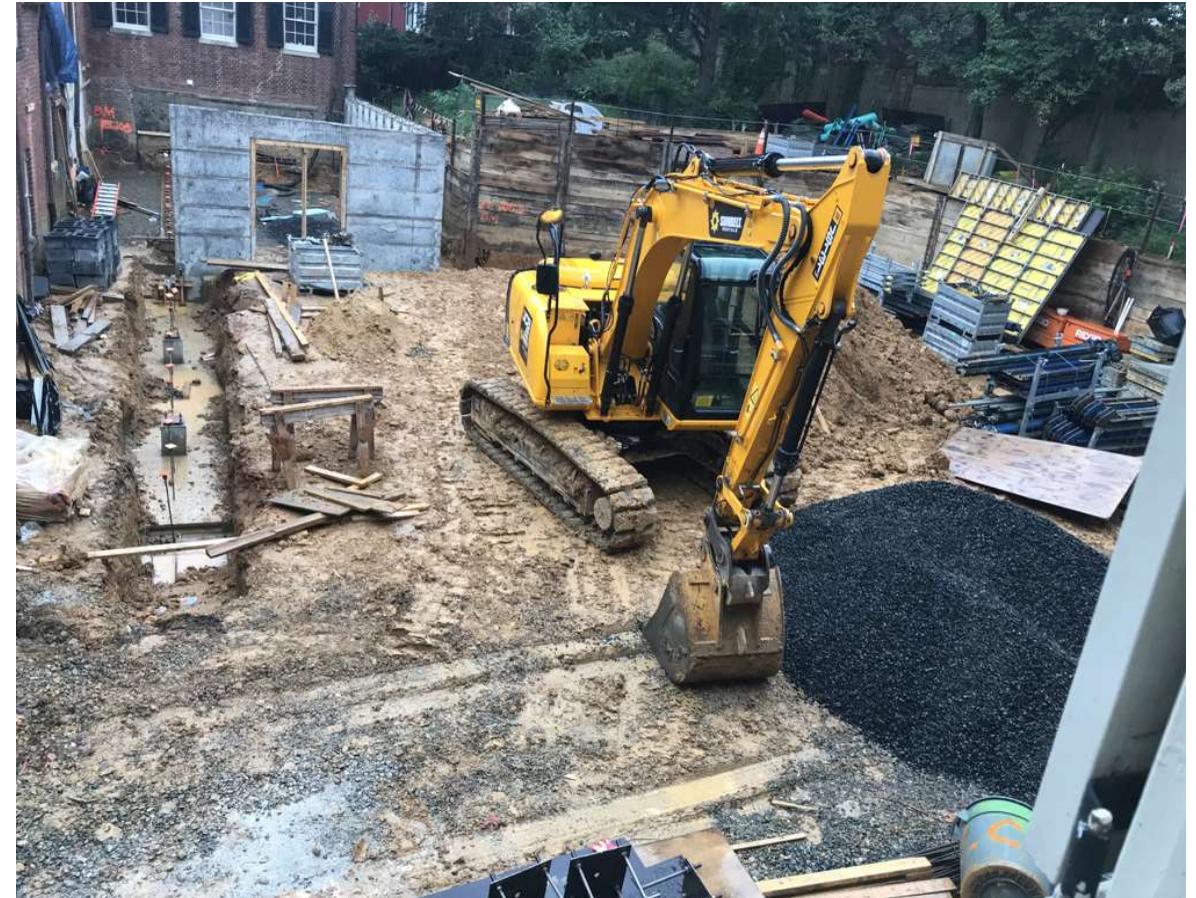
But you can see that a new wall has been unveiled. The outlines of the Storage Room are clearly visible, as is the door into that room from the new Assembly Room Terrace, and the rough outline of that terrace.

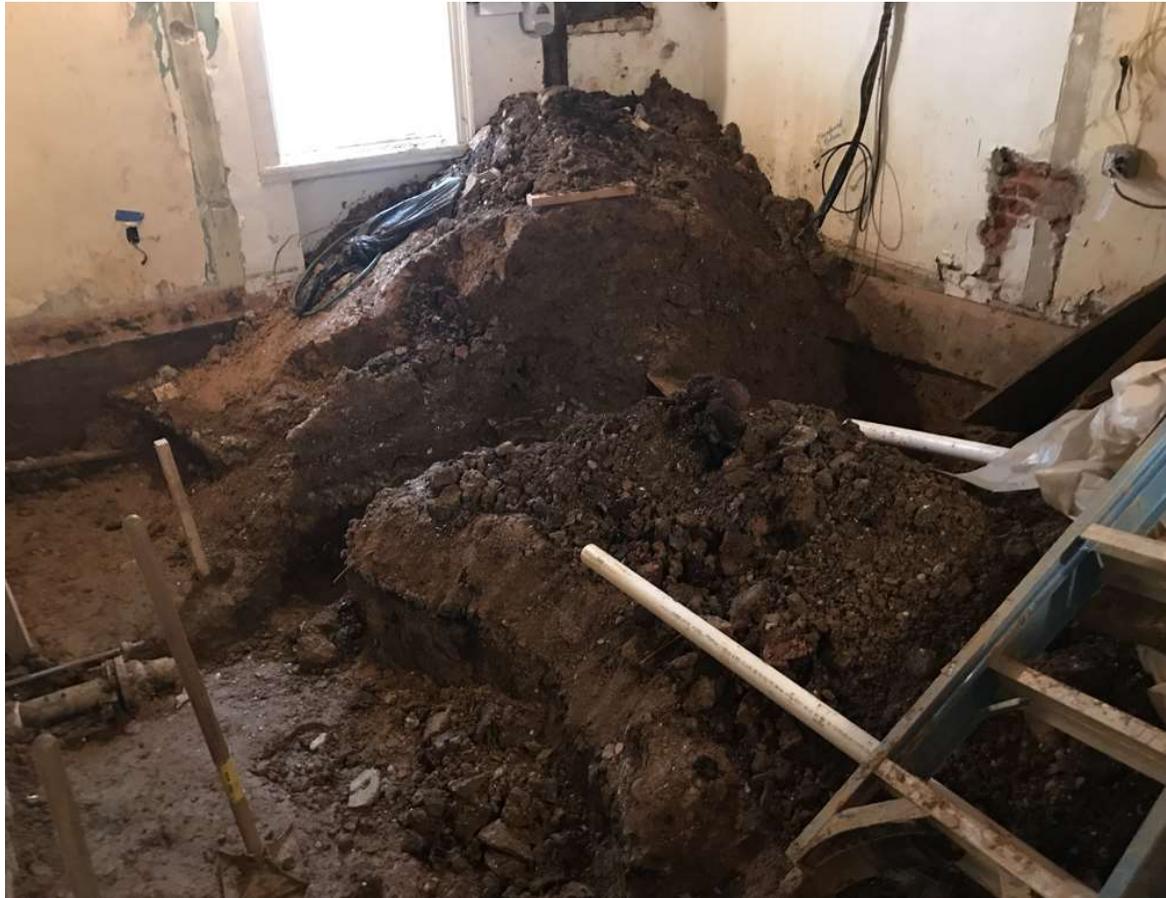
They are now working to lay the basis for the recreated kitchenette and the new ADA accessible bathroom. Having discovered that the sewer connection does not go out into the street here, as we thought, they are pursuing it eastward.

On the left, the completed sprinkler connection is now underground waiting for the next step.

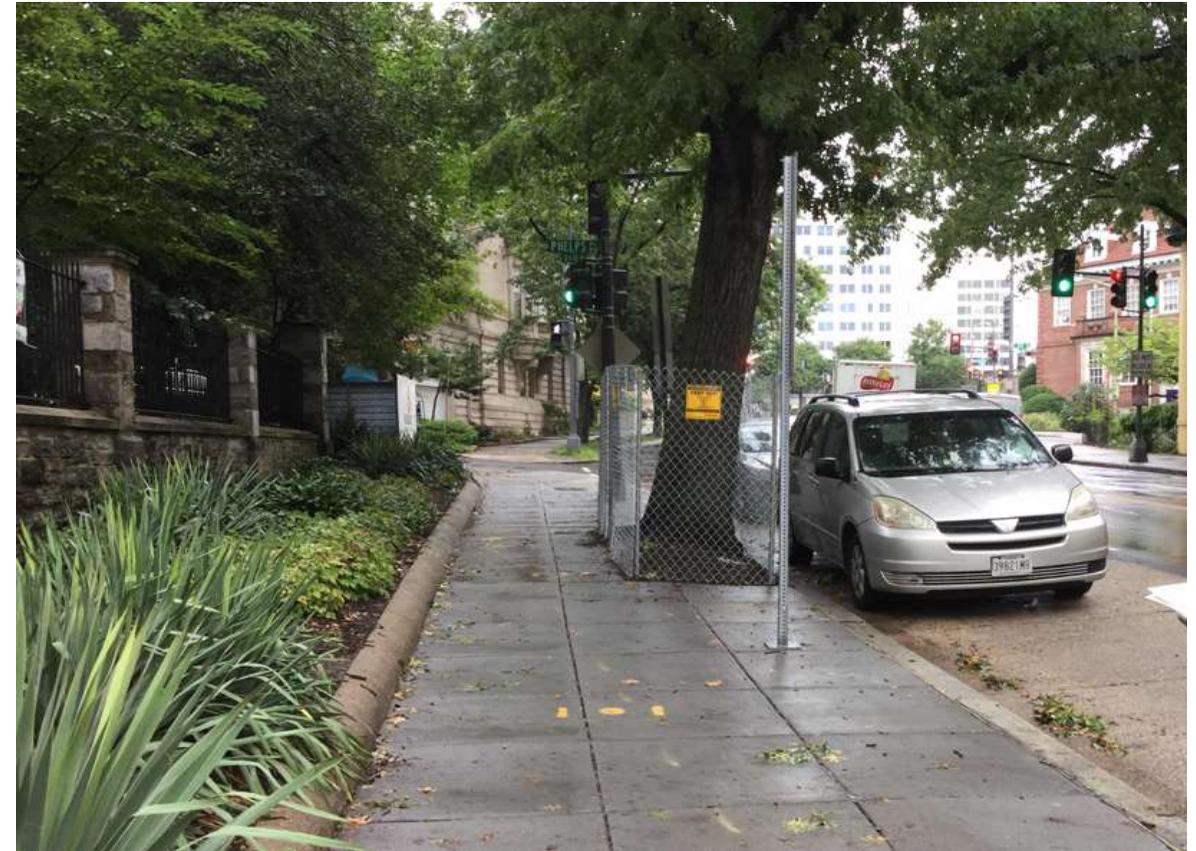
A large new drain line for the new bioretention pond will soon run down the space between the tree and the wall, creating some issues for the sidewalk, the planting bed, and the rush hour traffic.

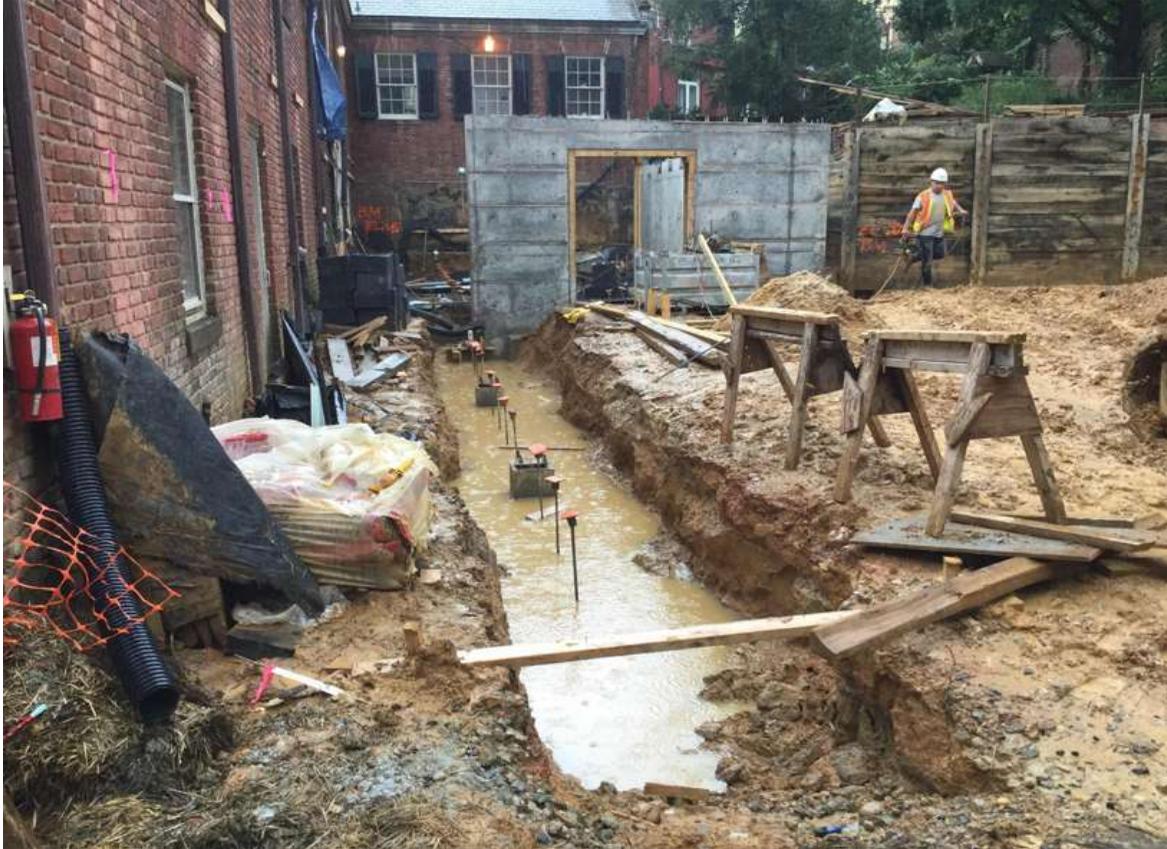
Most things wait for the footings, and the footings wait for the sun, which appears too late in the day to be helpful.

Six concrete persons lay gravel for the storage room floor foundation but are gone by 9 am.

The orange hats on top of each steel reinforcement bar are called “anti-impalement caps.” They protect against injury if someone should slip in the mud.

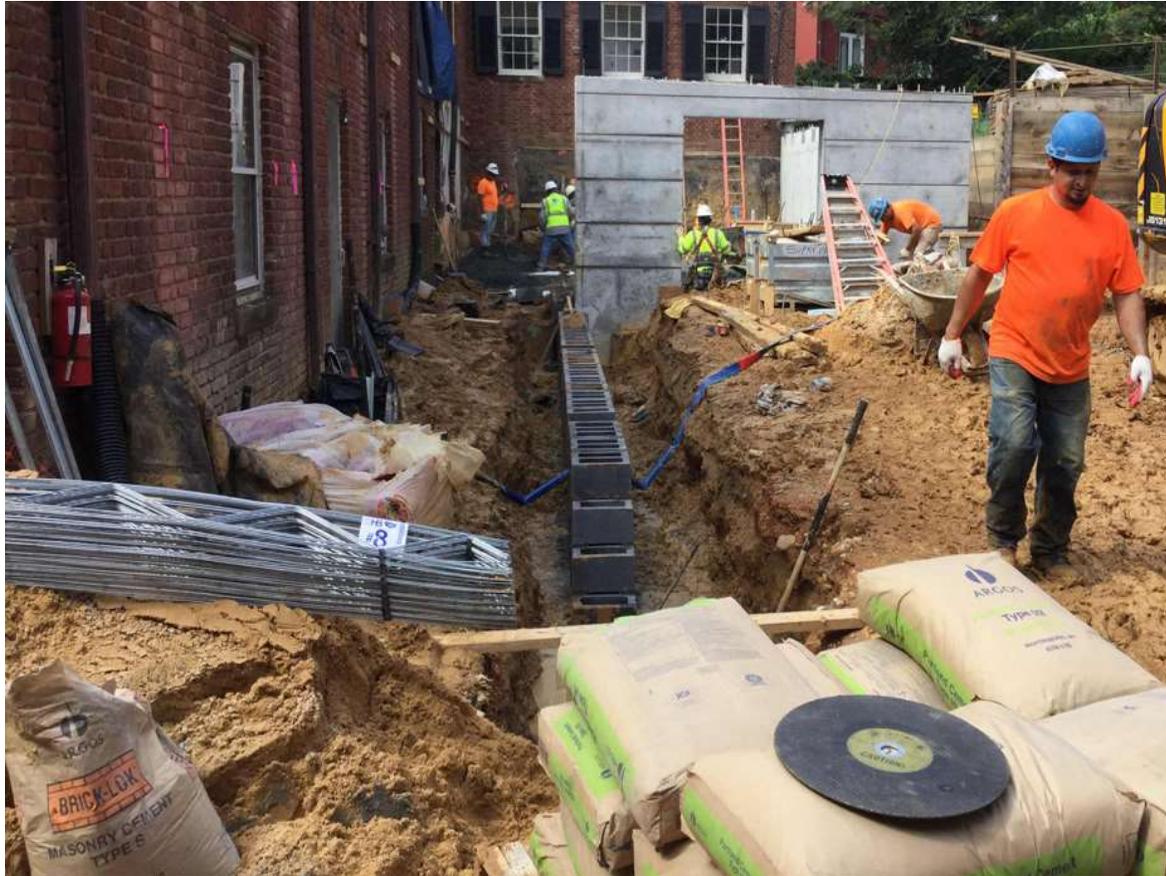
Three masons install block for the foundation of the corridor walls and begin to build up the fourth and last wall of the Storage Room.

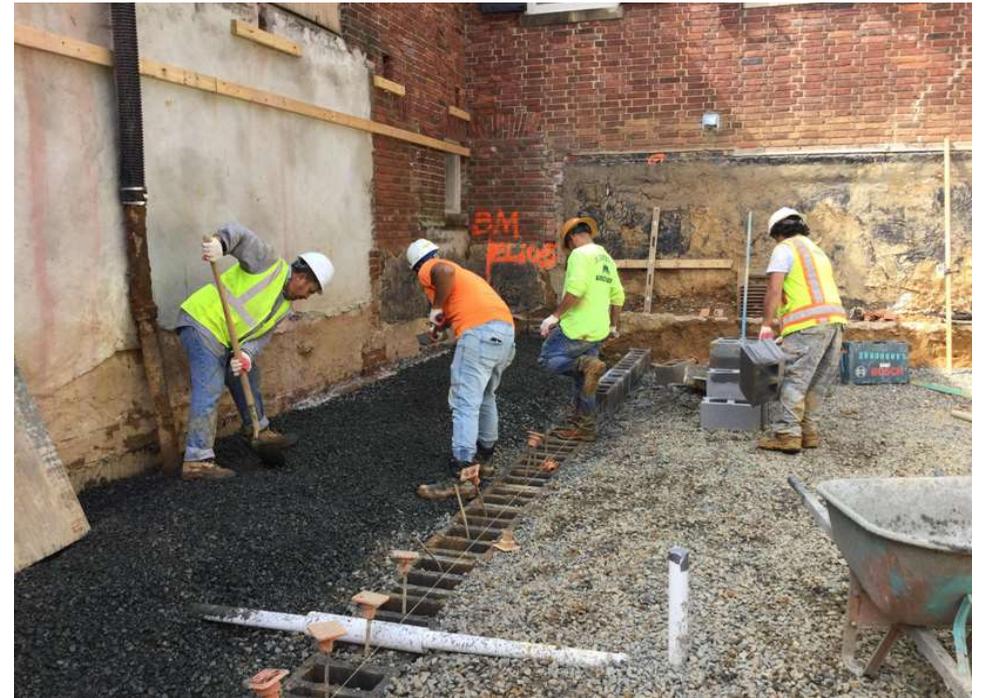
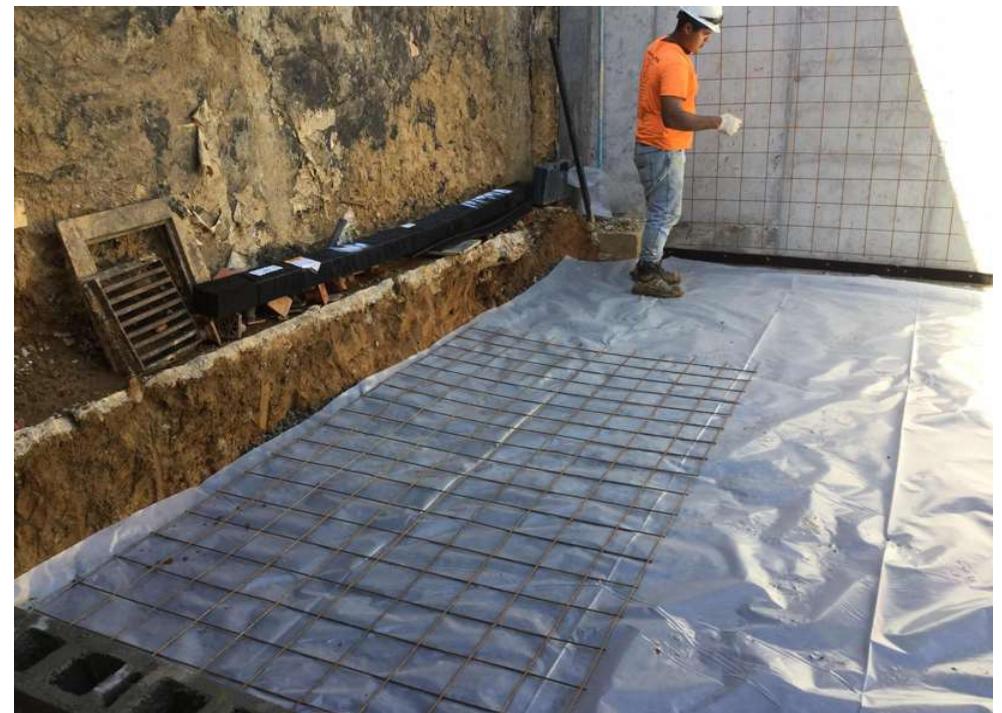
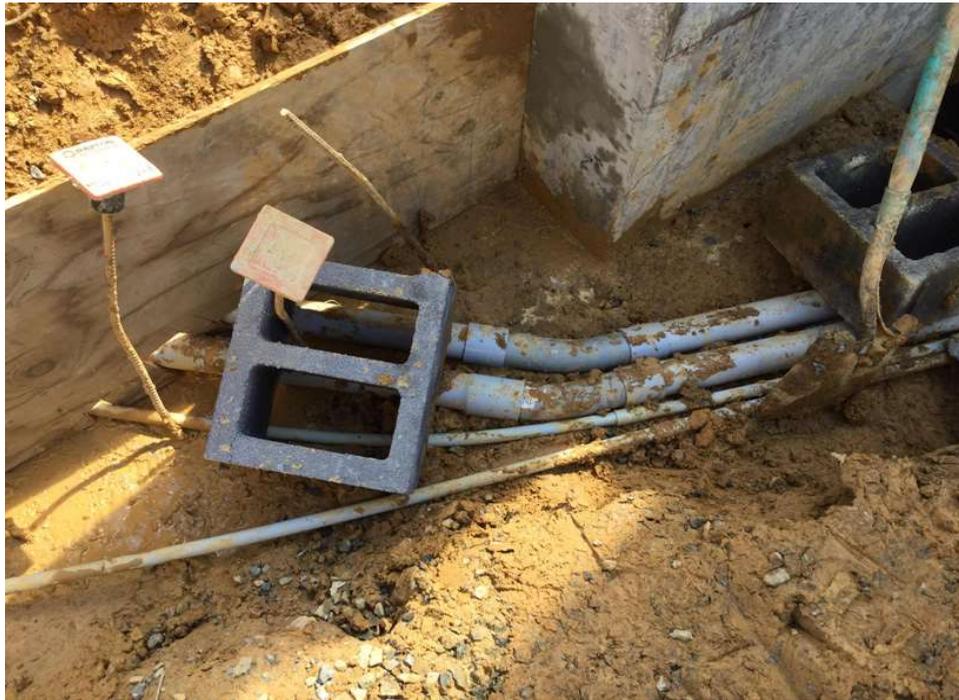
Ten concrete workers prepare the way, with crushed stone, a vapor barrier, and reinforcing steel, to pour the floor of the Storage Room and adjoining corridor.

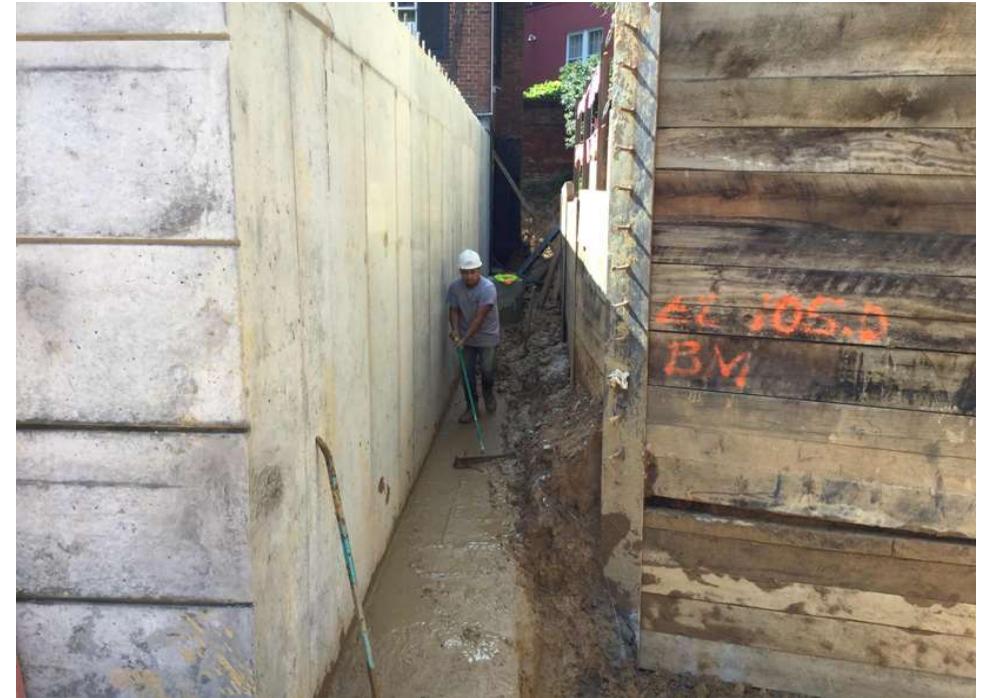
Gradually, the chaos and mud is receding and being replaced by bits of order and structure.

At least a quarter of the way through, creeping up on a third.

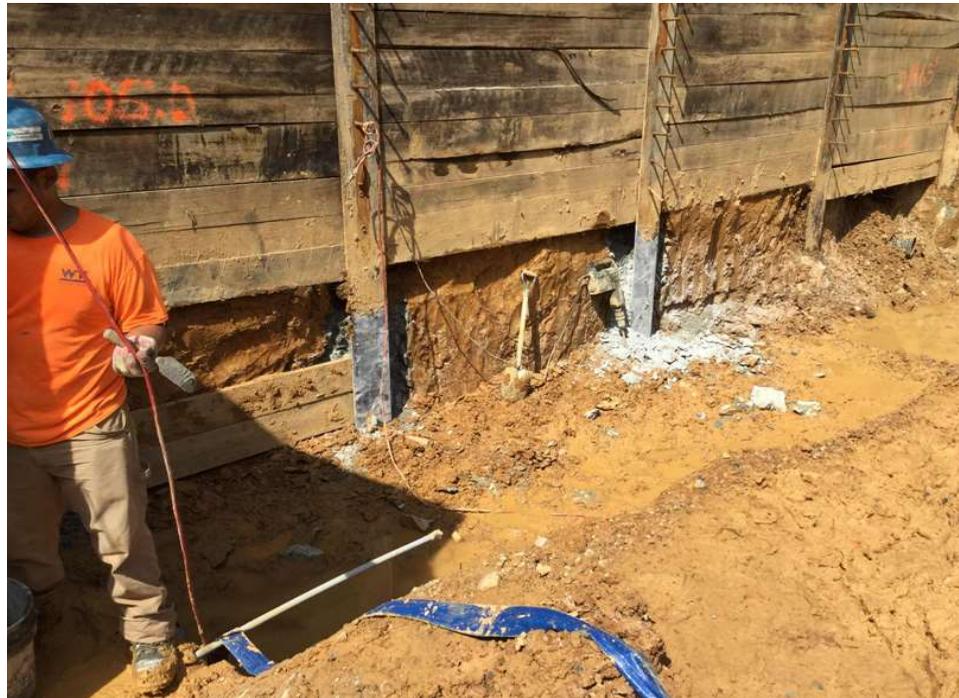
Three shoring workers extend the lagging (wood bits) downward to fill gaps exposed by recent excavation work.

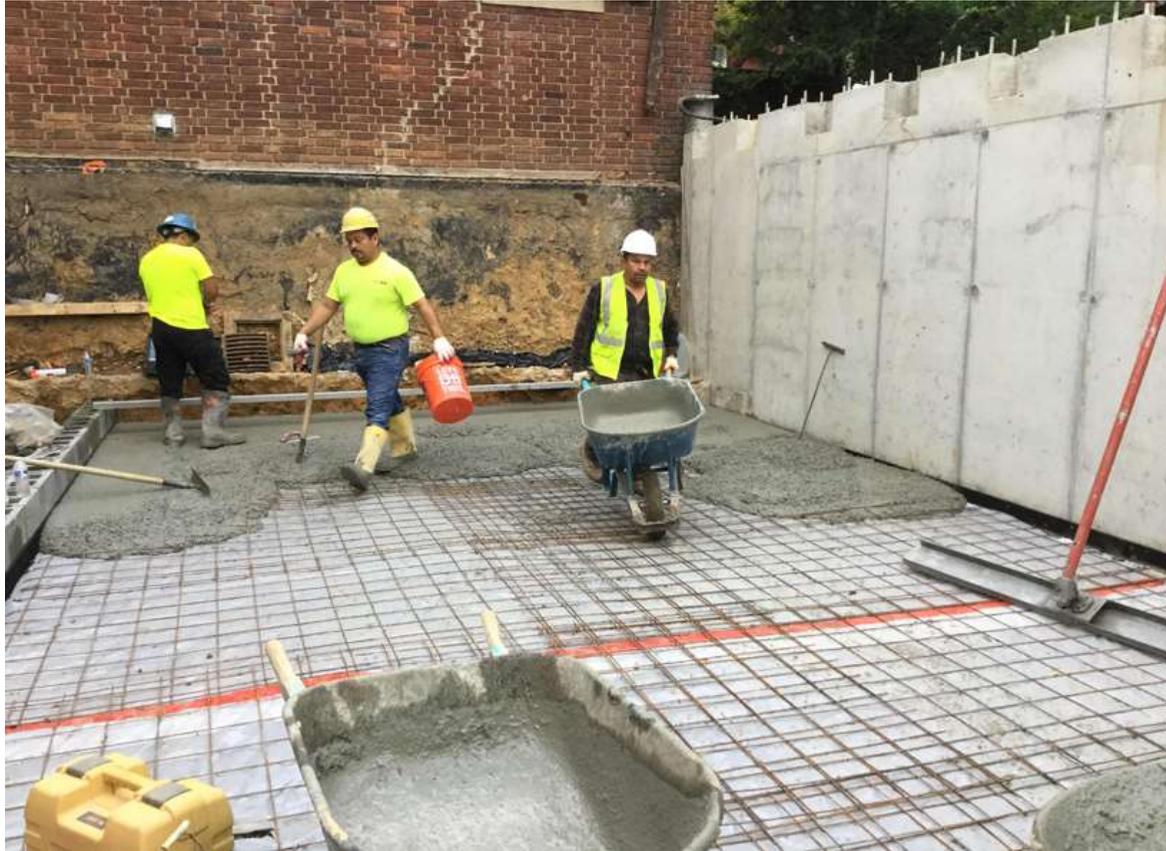
By 7:30, they are pouring the new floor slab:

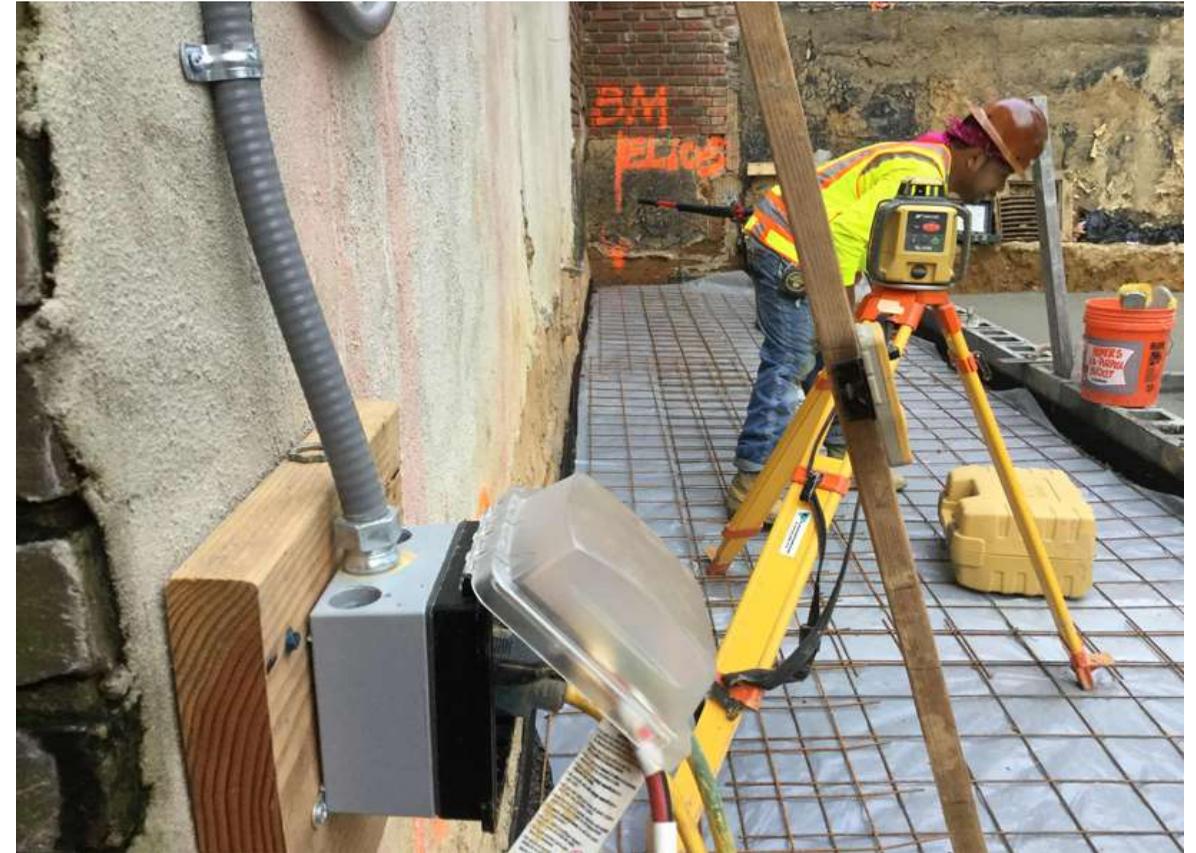
An hour later, they have completed a flat slab, with the aid of modern gadgetry like this self-leveling construction laser.

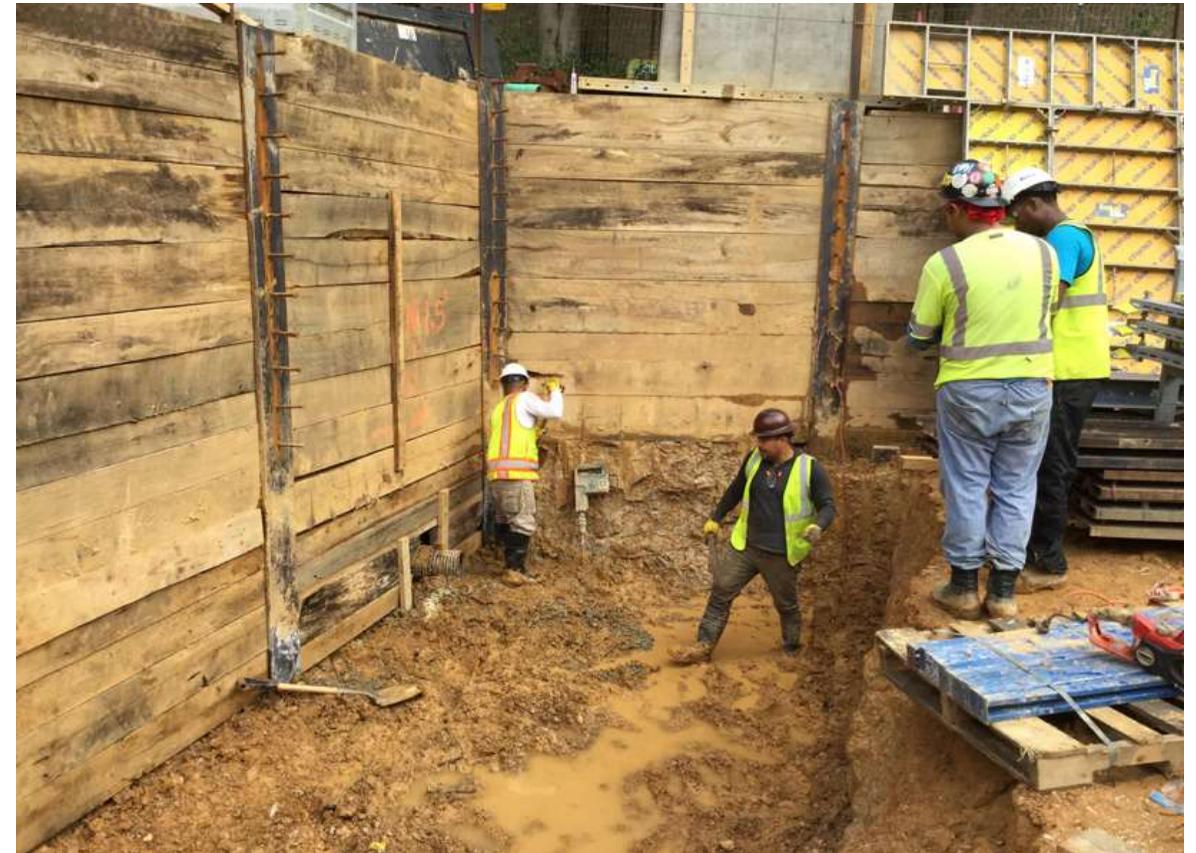
They also excavate north of the Storage Room, preparing to pour the foundation of the new outdoor stairs that will connect the upper and lower terrace levels:

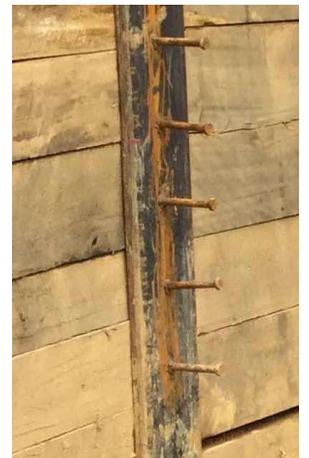
If you look closely, you can see the Nelson studs that they earlier spot-welded to the vertical steel pilings. The wall will be poured over these studs, which help attach the wall to the pilings.

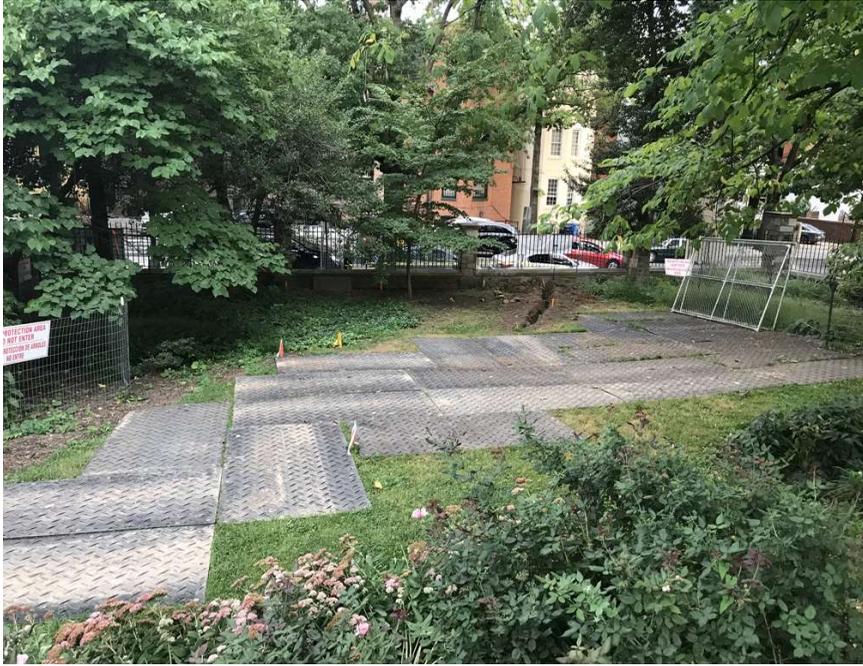
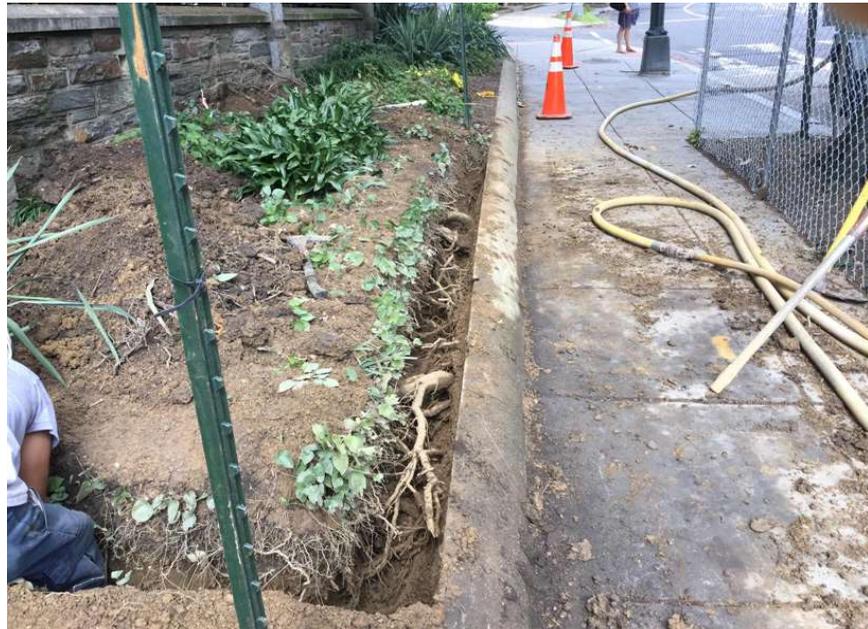
They also trench and cut some roots that would otherwise be shredded by the work.

Outside the walls, they uncover roots of the street trees, because the DC arborists want to be notified of any roots greater than two inches that will be affected by the planned drainage work.

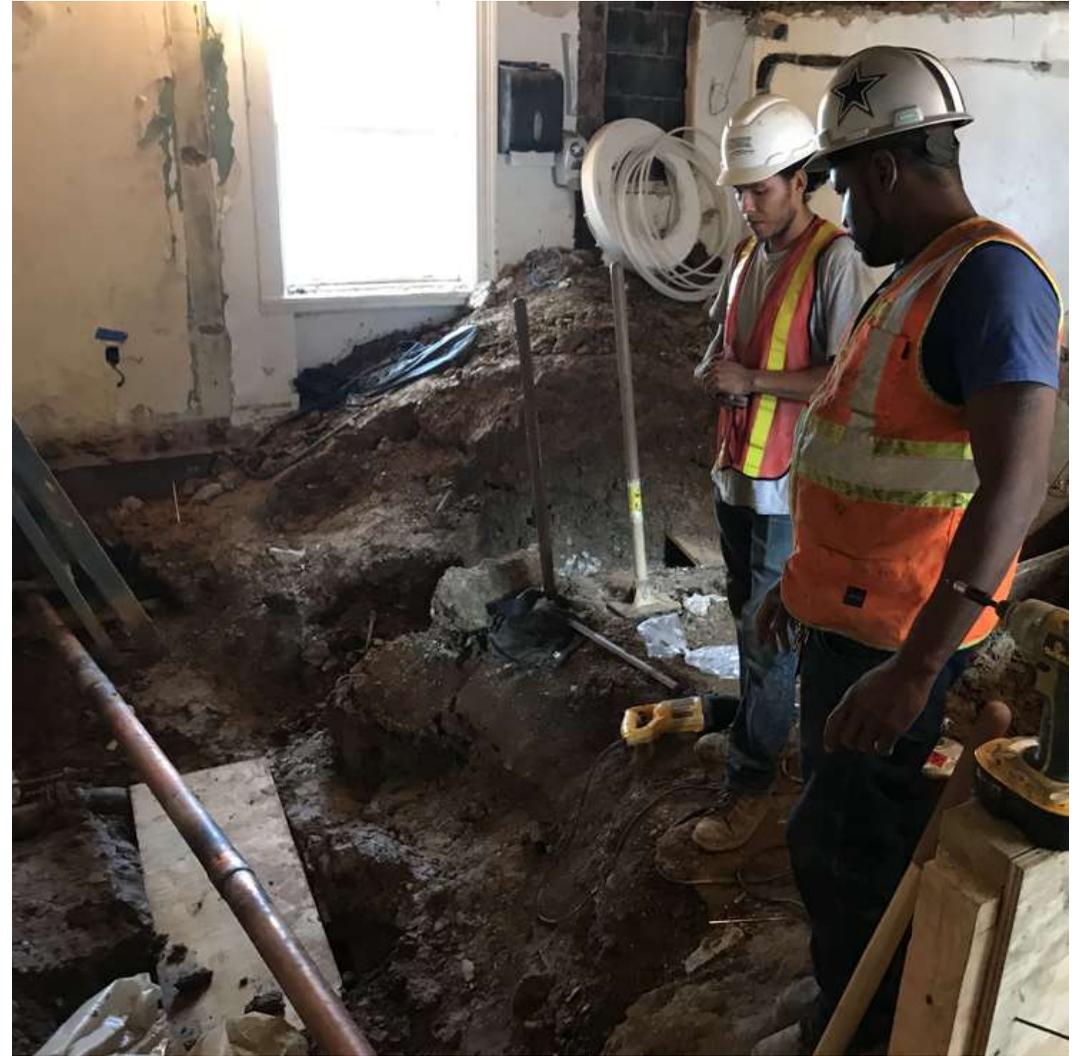
Three plumbers work inside Carriage House. The latest addition is this big, copper pipe, which we hope will be of no use.

It will connect to a hydrant on the outside wall of Carriage House.

The Fire Department would pump water into that hydrant to add pressure to our fire sprinkler system if that ever becomes necessary.

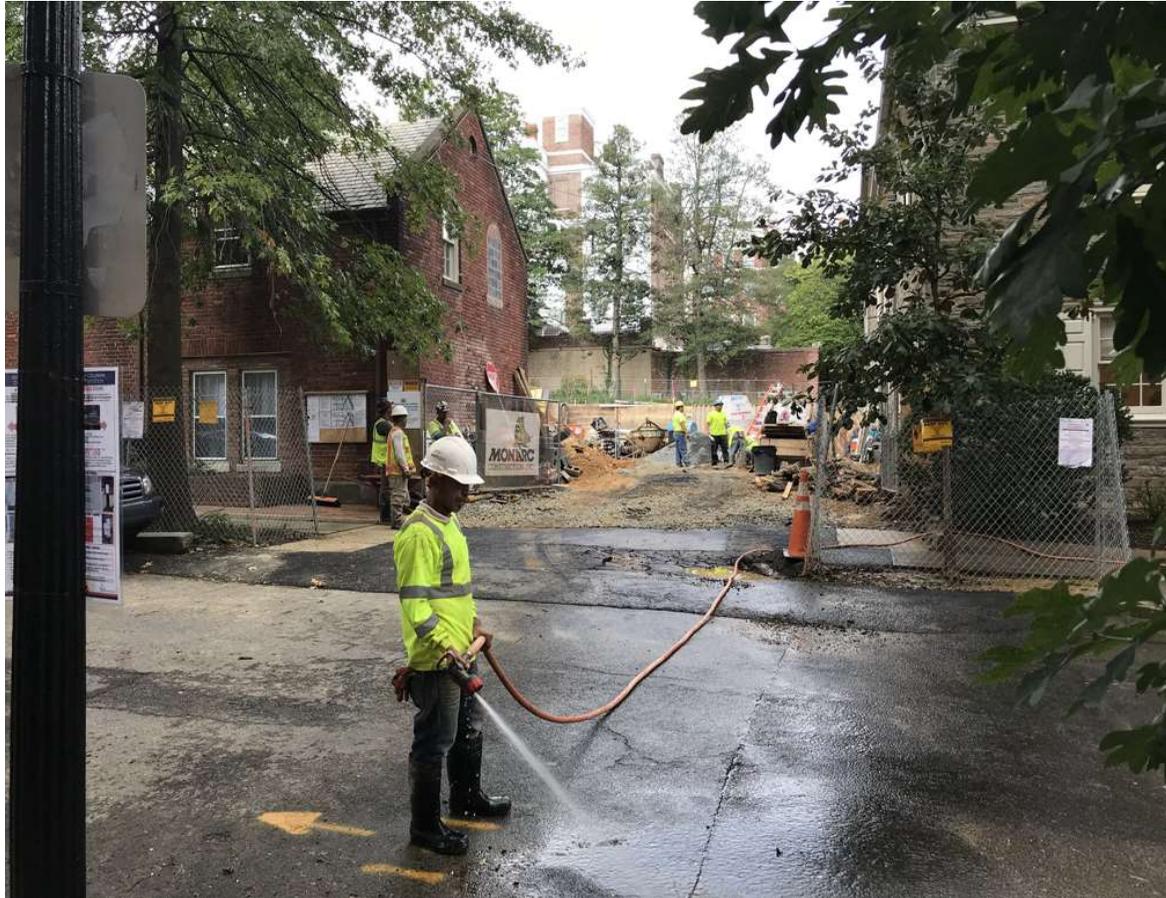
When a truck comes on site, its wheels are washed on the way out, to prevent the mud from spreading.

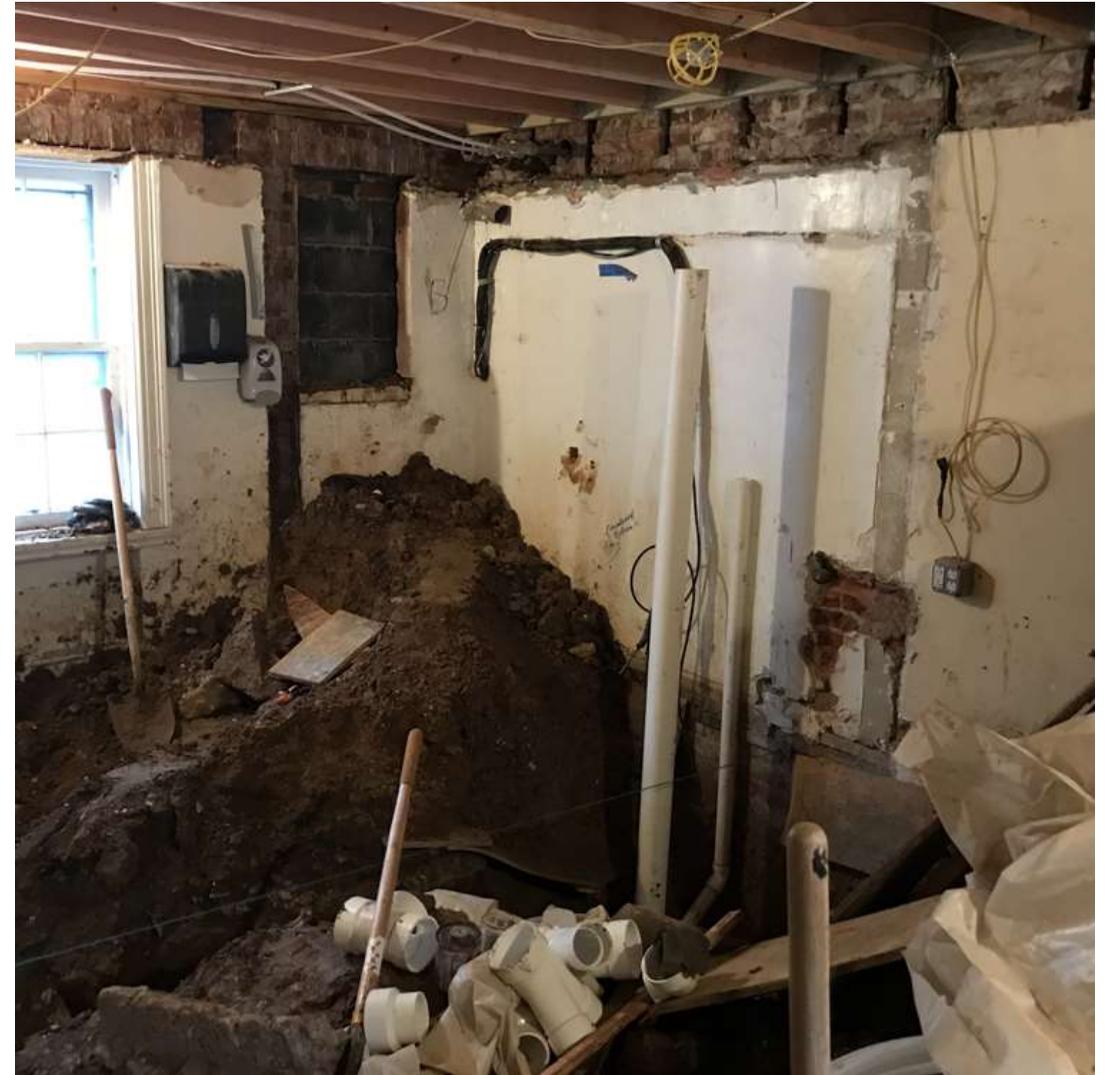
Fortunately, eleven concrete artisans appear and start arranging steel for the scheduled pouring of the stair foundation.

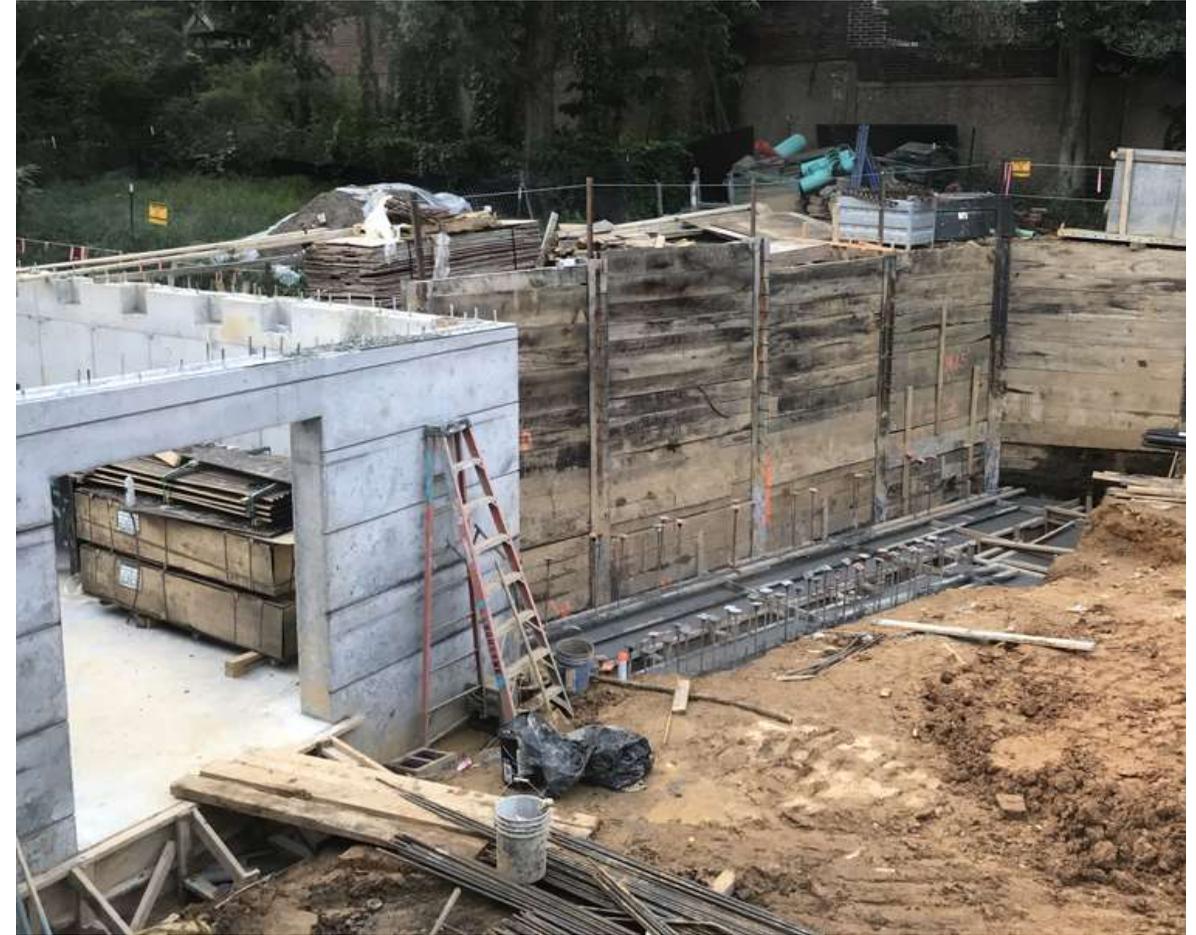
By the end of the day, the foundation is in place.

The row of steel rods closest to the shoring will anchor the retaining wall along the upper terrace. The nearer row will anchor the right side of the stairs, descending left to right from the top of the Storage Room, with the bottom landing at the far right.

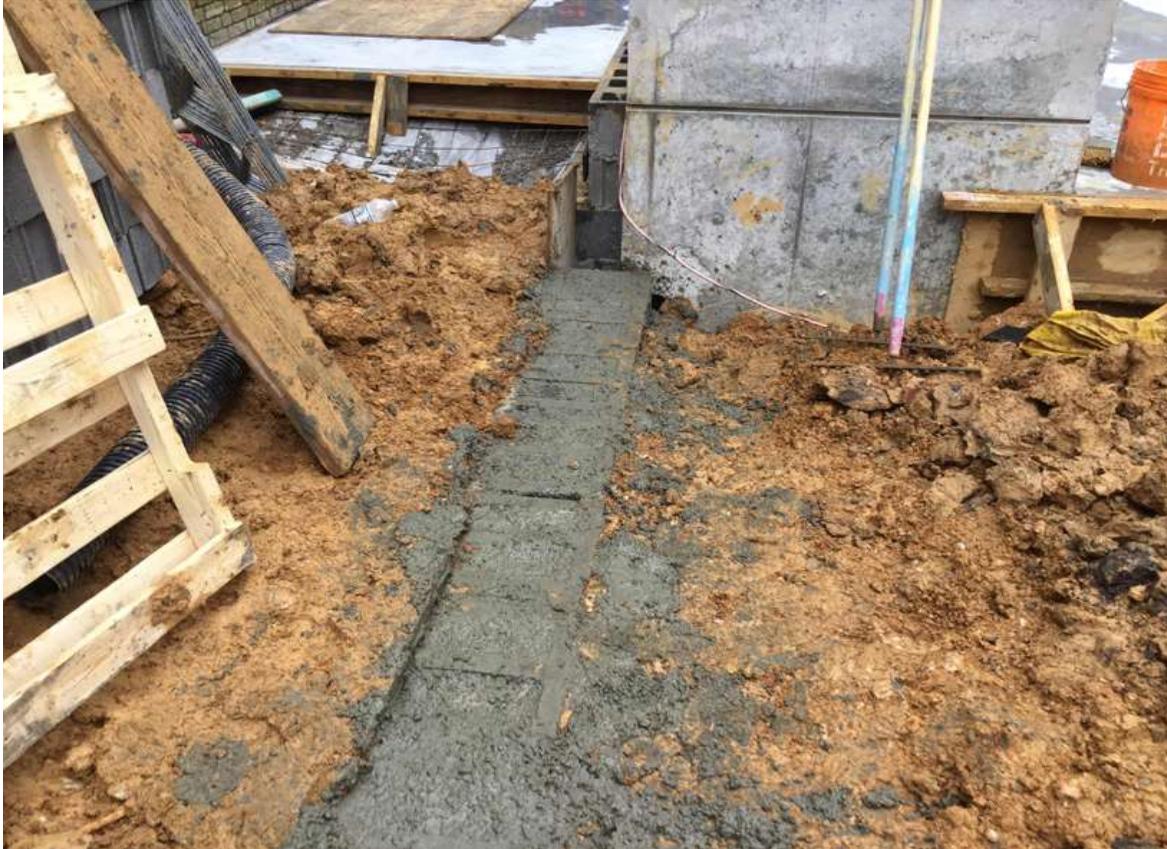
Four masons come and grout the blocks that will support the corridor wall along Carriage House.

There is a poured concrete foundation underneath, but from here this wall will rise up in steel, wood, glass, stone, insulation, etc.

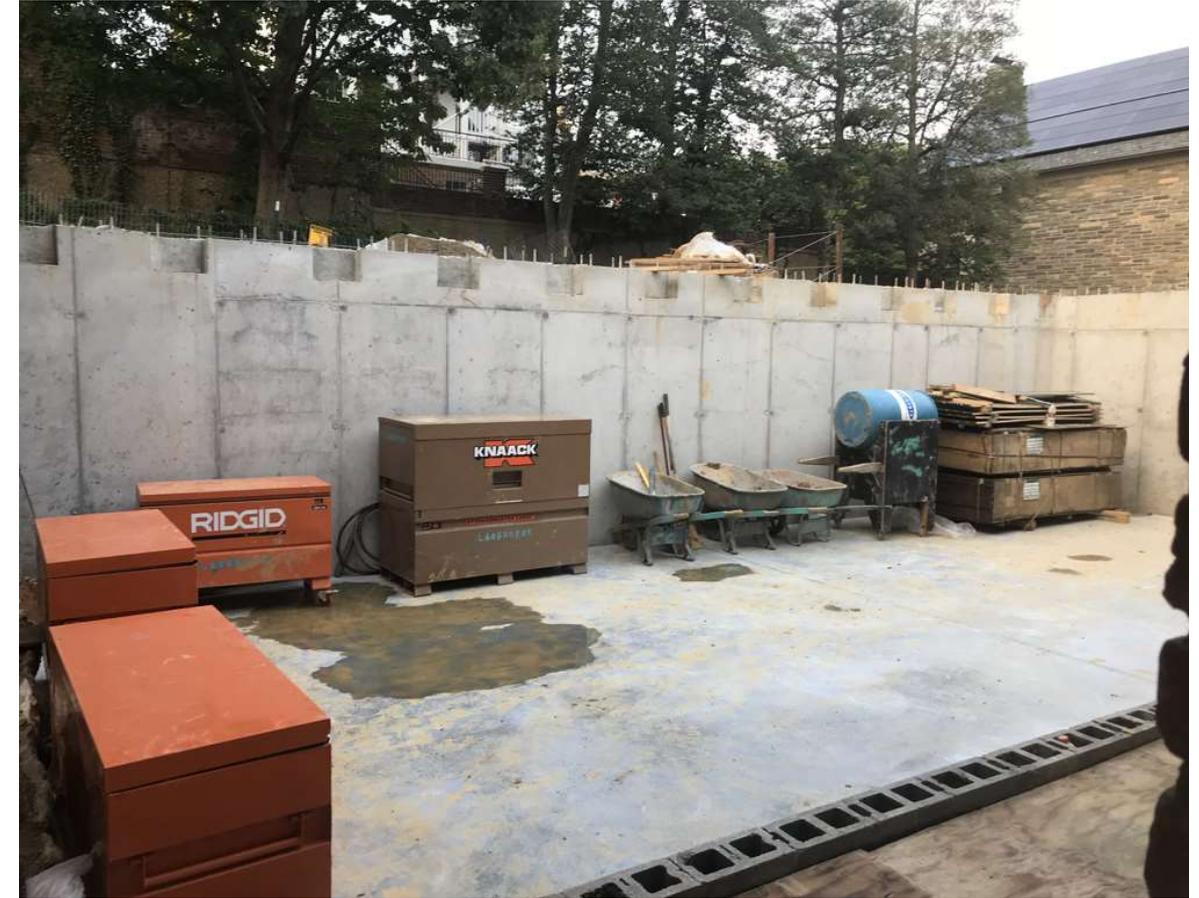
As the week ends, the Storage Room begins to earn its name.
