FMW Renovation Update

September 9, 2018

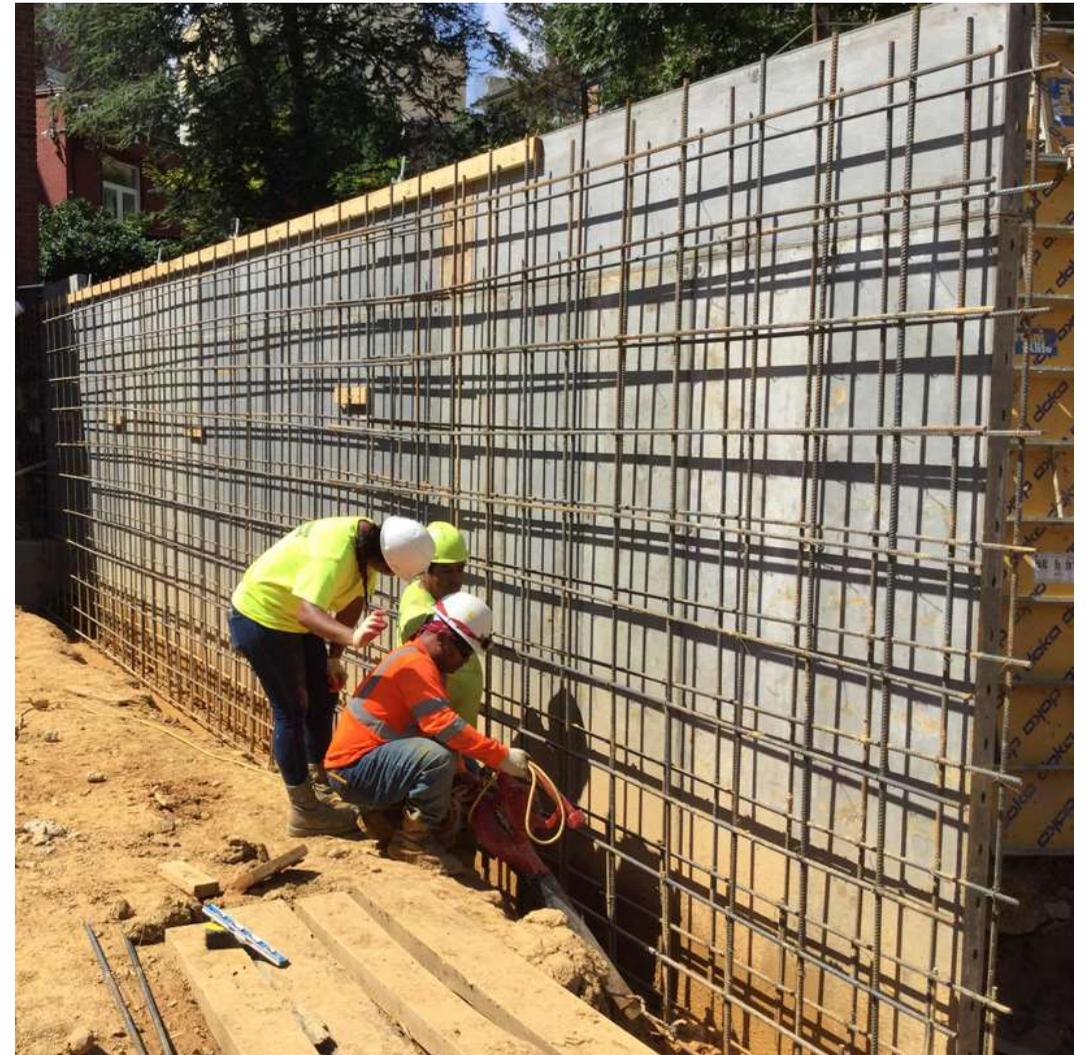
Progress. The concrete crew finishes the reinforcing steel assembly for the new wall.

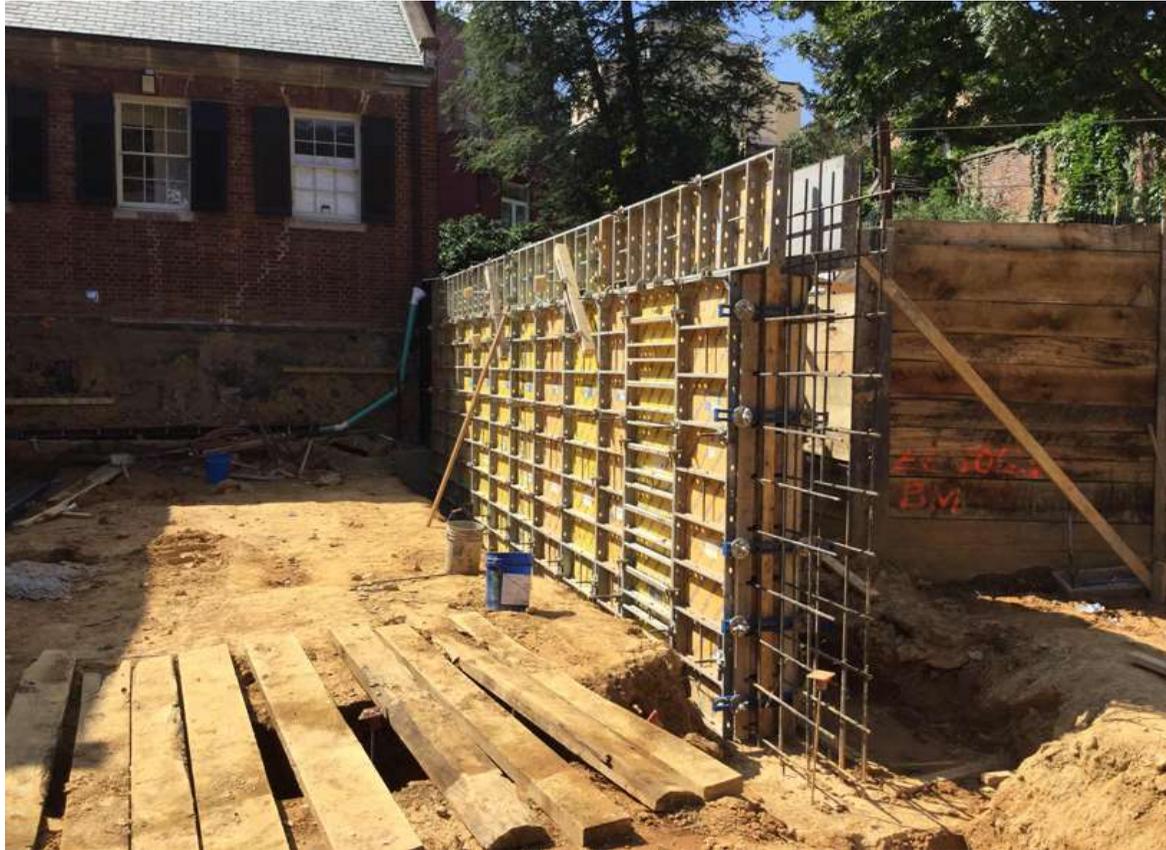
The steel passes inspection and the crew adds another layer of form panels, facing the first.

The concrete will be poured over the reinforcing steel between the metal panels.

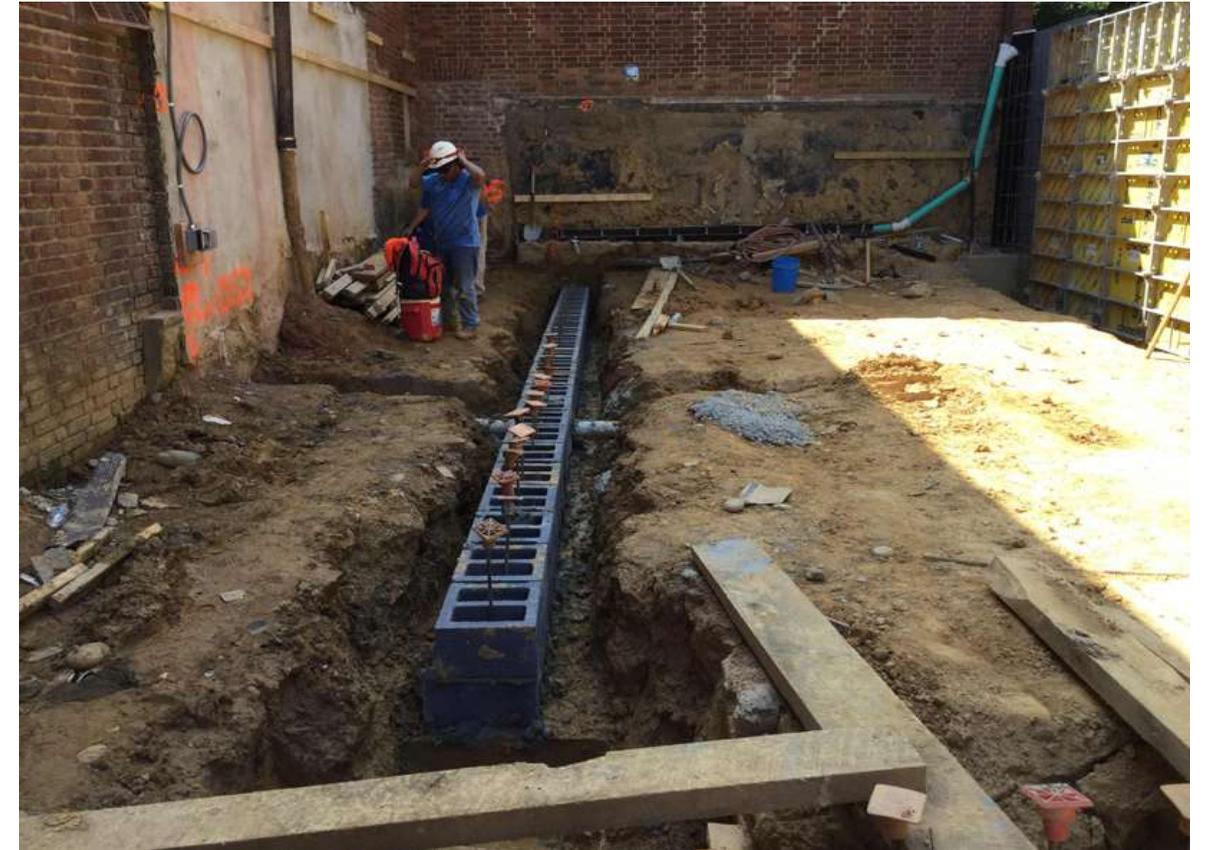
In an exciting new development, the masons, having completed their work on the beam pockets, return and begin laying up concrete blocks to create the opposite wall of the Storage Room, separating it from the new ground floor corridor.

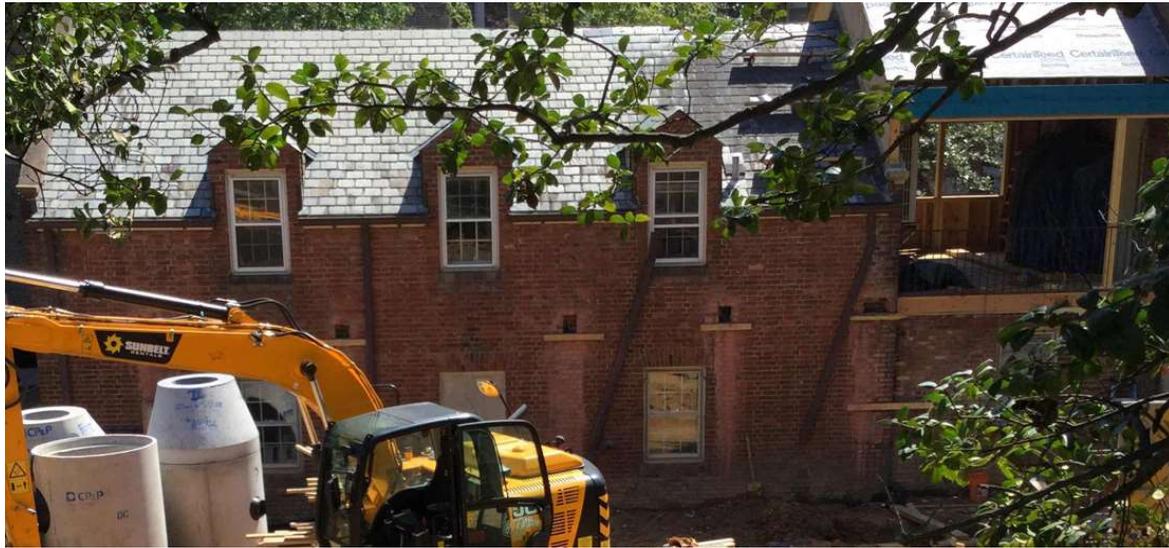
Here are the completed beam pockets:

You may notice that the pockets don't run straight across, but rise from left to right.

The floor of Quaker House Living Room is about 8½ inches higher than the upper floor of Carriage House, so the corridor has to ramp up slightly as it passes between them. The beams that go in these pockets will support that ramp.

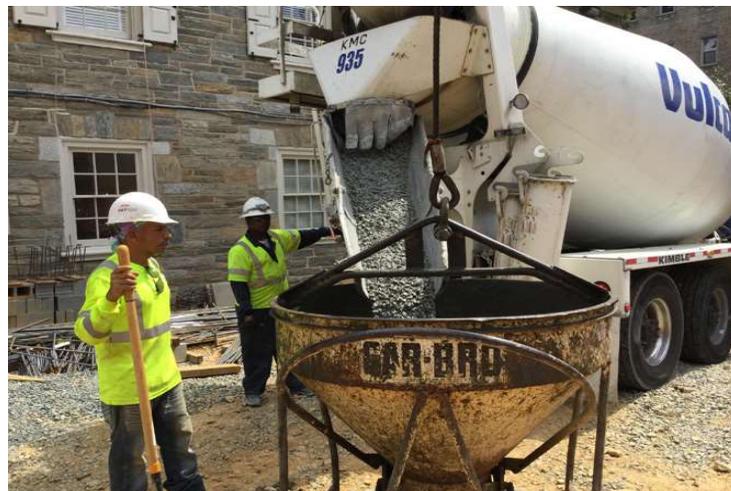
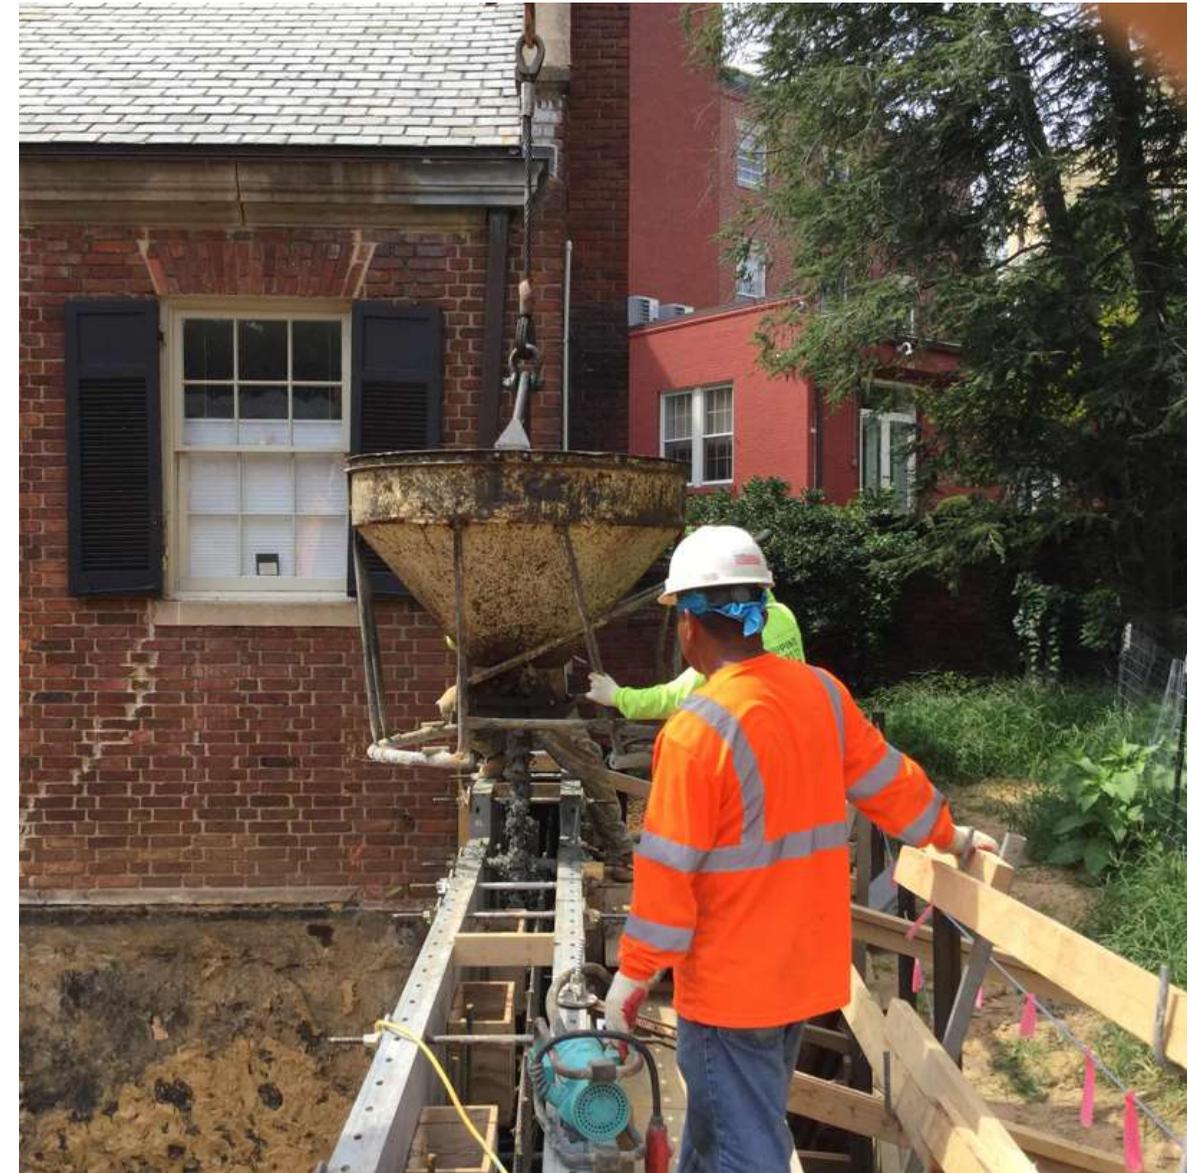
Notice the little boxes at the top, inside the form? Those are beam pockets that will hold the other end of the support beams.

On the other side, they make beam pockets by *making* holes in the brick. On this side, by *leaving* holes in the concrete. The boxes keep the concrete out.

The blue thing is a giant vibrator that they use to shake the concrete to get rid of any air pockets.

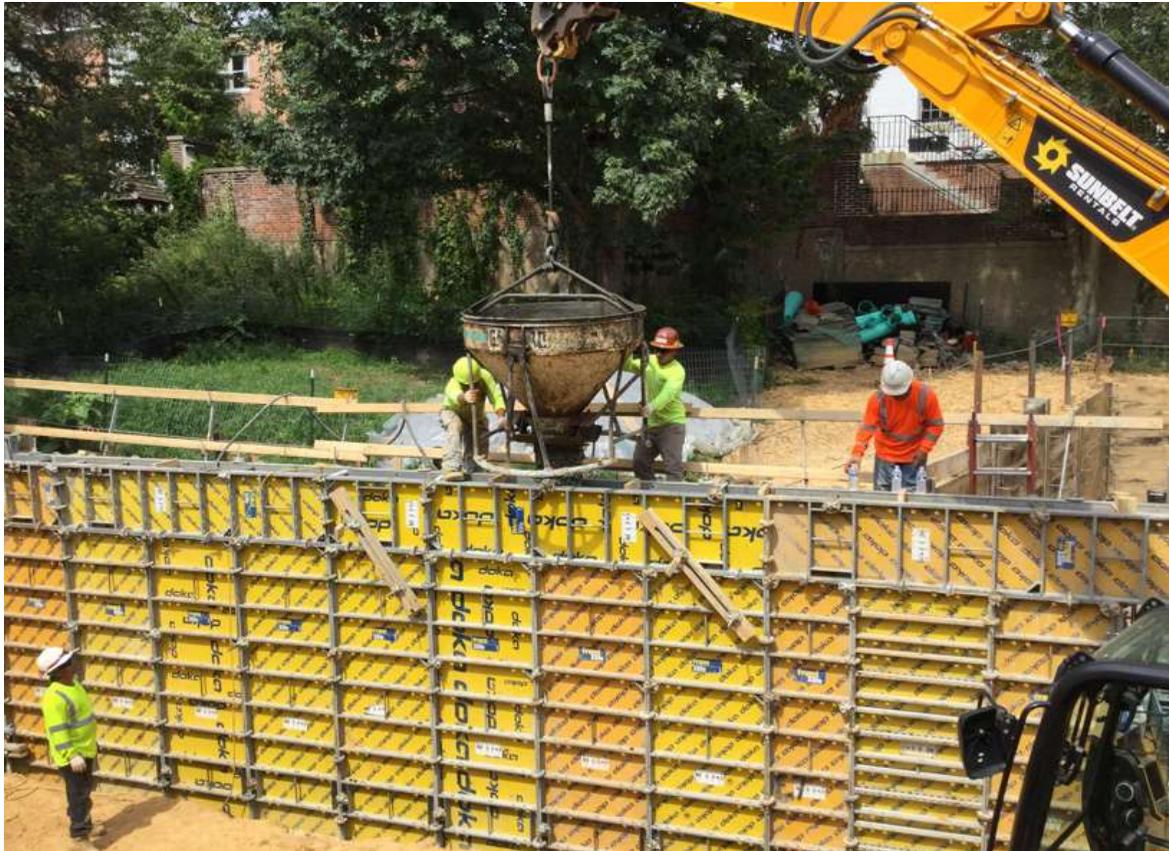
The inspector takes samples of the concrete to make sure it's the good kind.

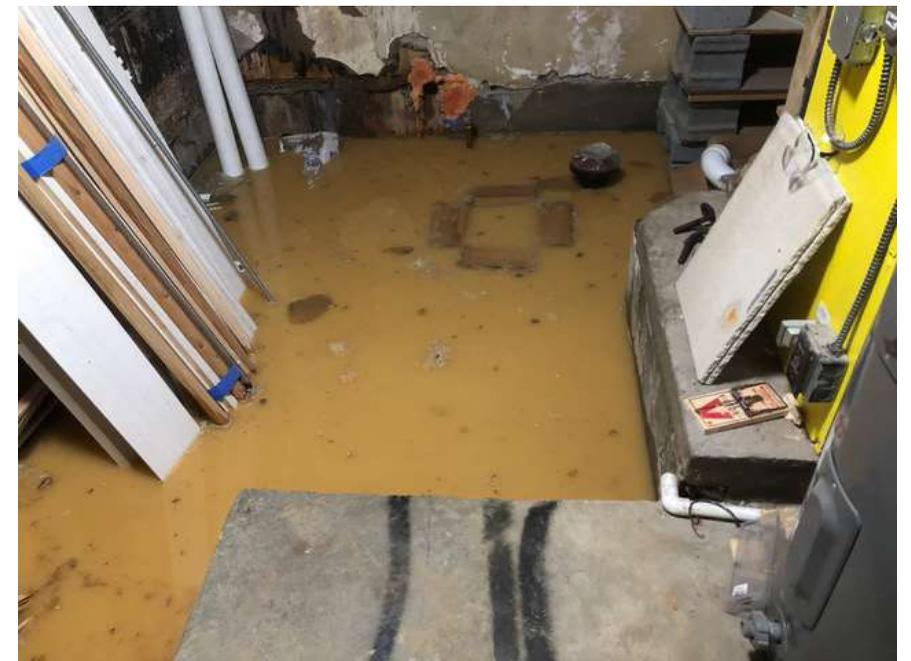
The plumbing work between Quaker House and Carriage House has opened a hole into the new foundation trench and another hole between the two buildings. The water rises both outside and in.

Little damage, other than cleanup.

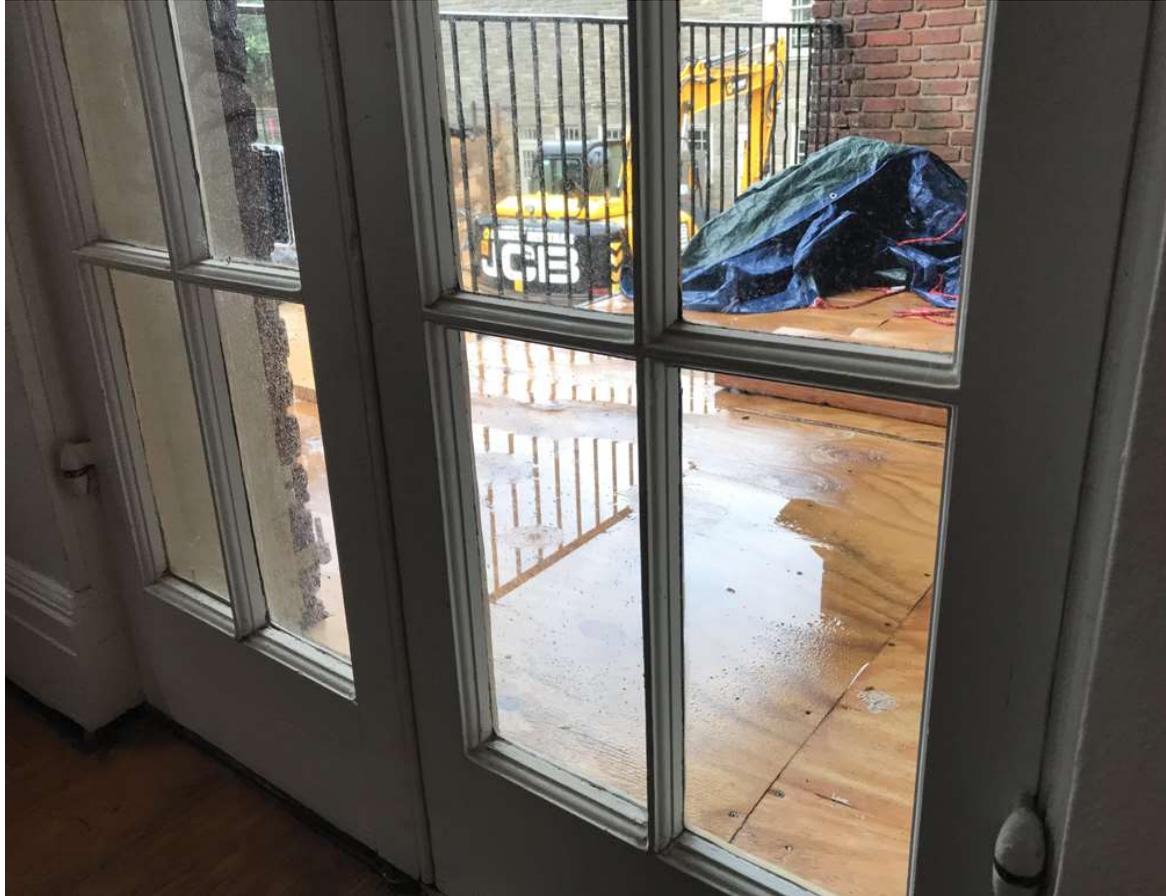
Rain soaks a section of the new Carriage House subflooring, warping some of it.

The new Carriage House subfloor may need some repair.

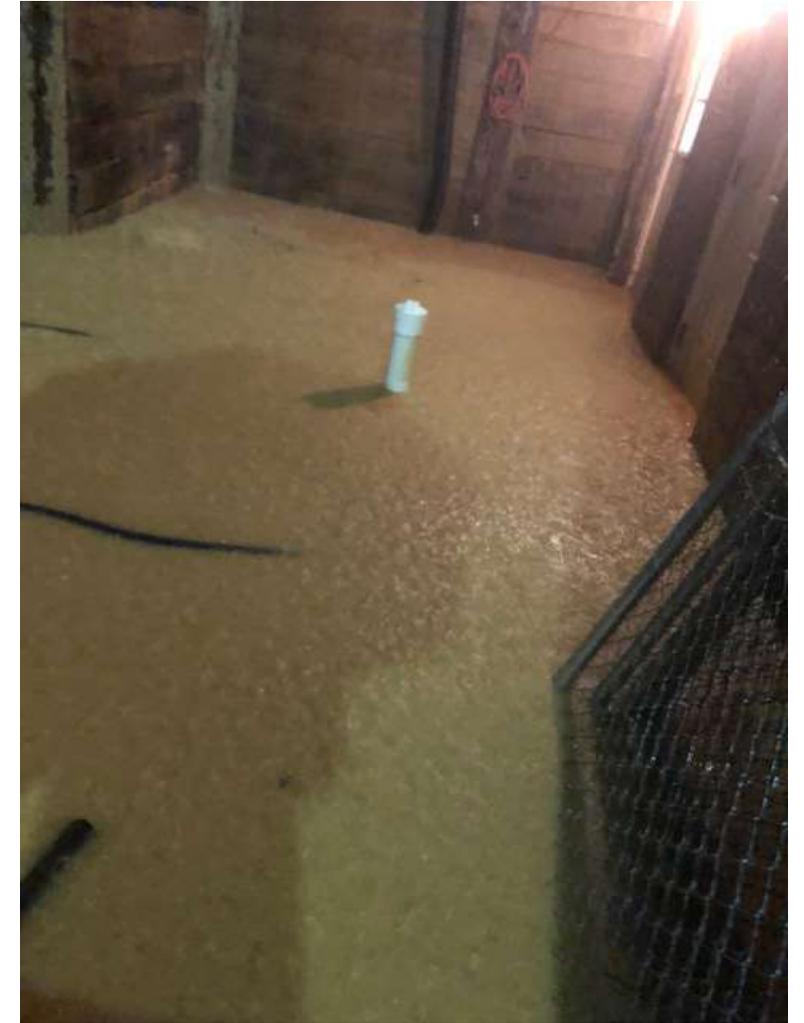
The central event, however, is the failure of the sump pump that was supposed to keep water from filling the low spot outside the kitchen door.

The pump is not up to the task, and the discharge hose flails around and ends up pumping water back into the hole until the bottom of the kitchen door is under water.

It doesn't help that the manholes awaiting installation were moved on Friday to make room for future concrete work, and ended up partially blocking the drainage channel Monarc had dug from the kitchen ponding area.

And Ken, taking no chances, has caulked the kitchen door shut for the present.

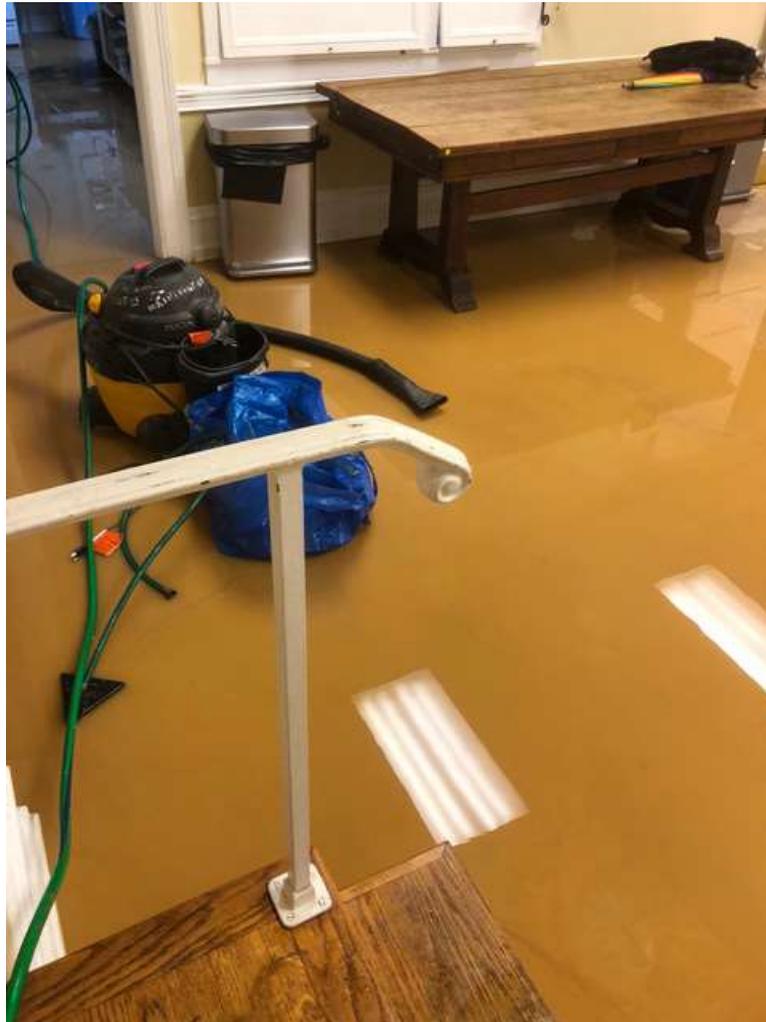
Hundreds of gallons of water flow under the door and out into the Assembly Room.

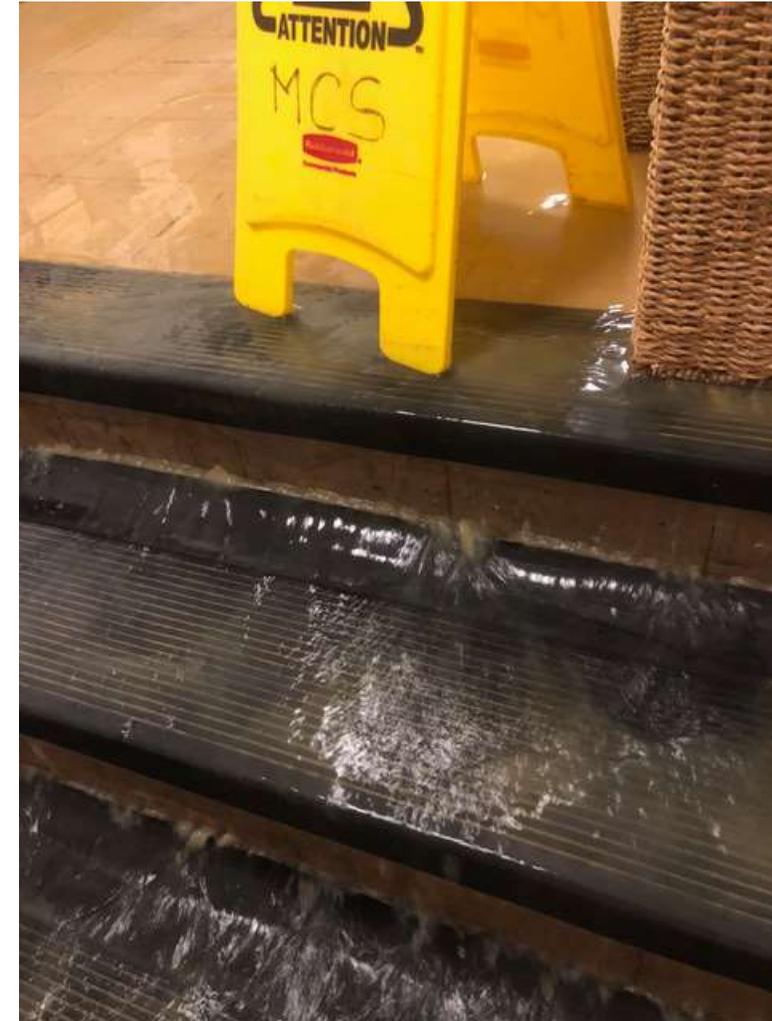
The river then flows out into the hall, invades the vault and the main office, and eventually cascades down the steps, branches left into Decatur Place Room, and eventually exits by the front and side doors.

McDonald Cleaning Service sends a four man crew in the morning with serious equipment to clean up the mud.
